AN INTEGRATED DECISION-MAKING PROCESS IN EMERGENCY CONDITIONS DUE TO GEOHAZARDS – A STUDY CASE

PIPELINE ROUTE AND PROFILE

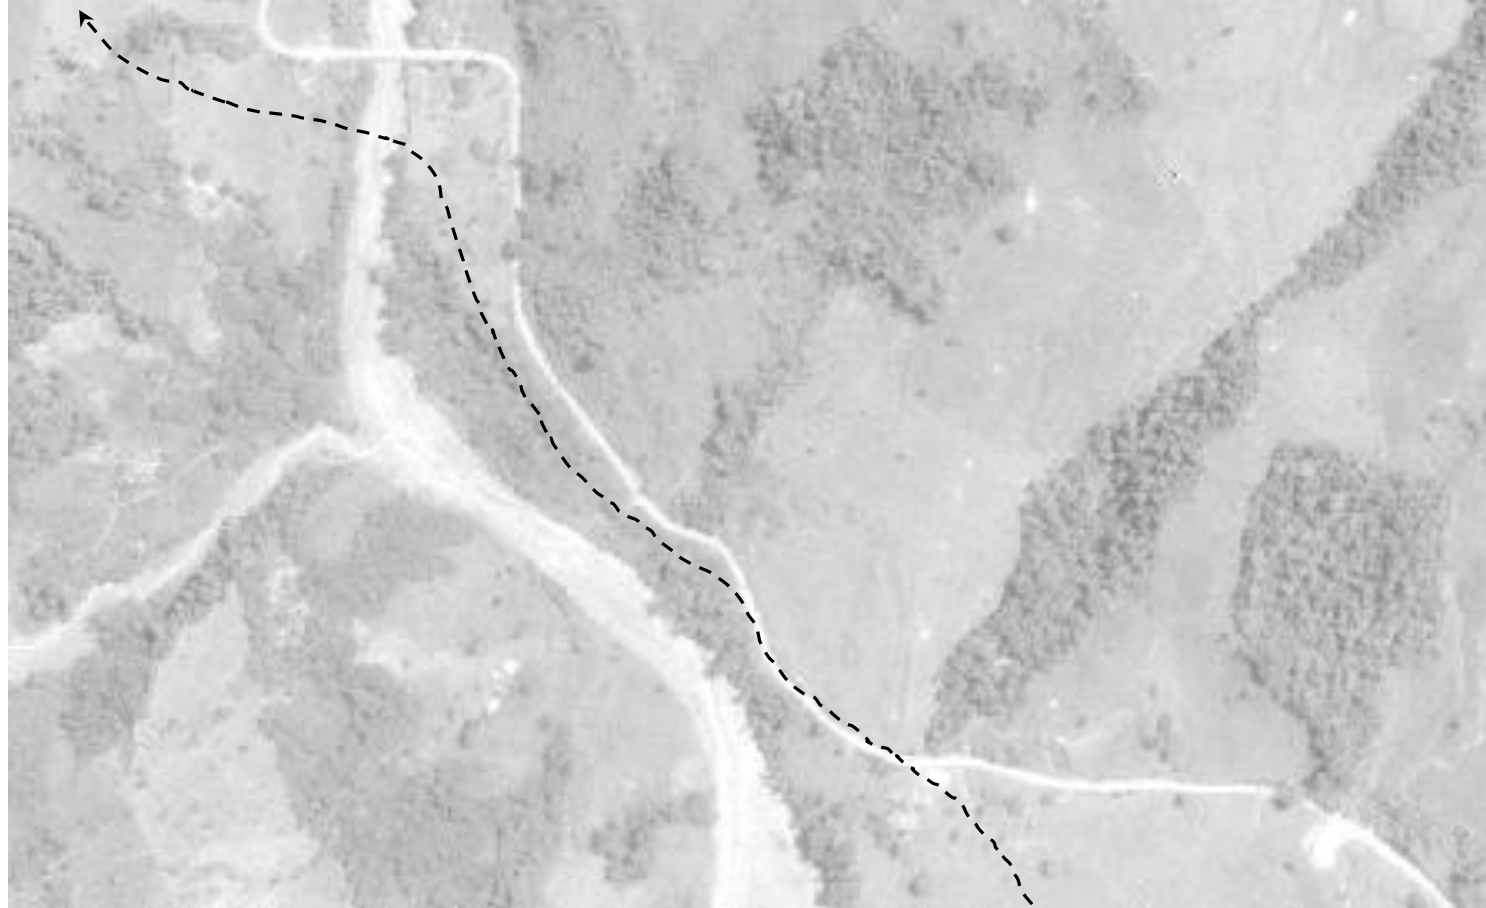
1982 Aerial photography prior to the pipeline construction. Note changes in land cover on the slopes. The black dashed line represents the pipeline location.

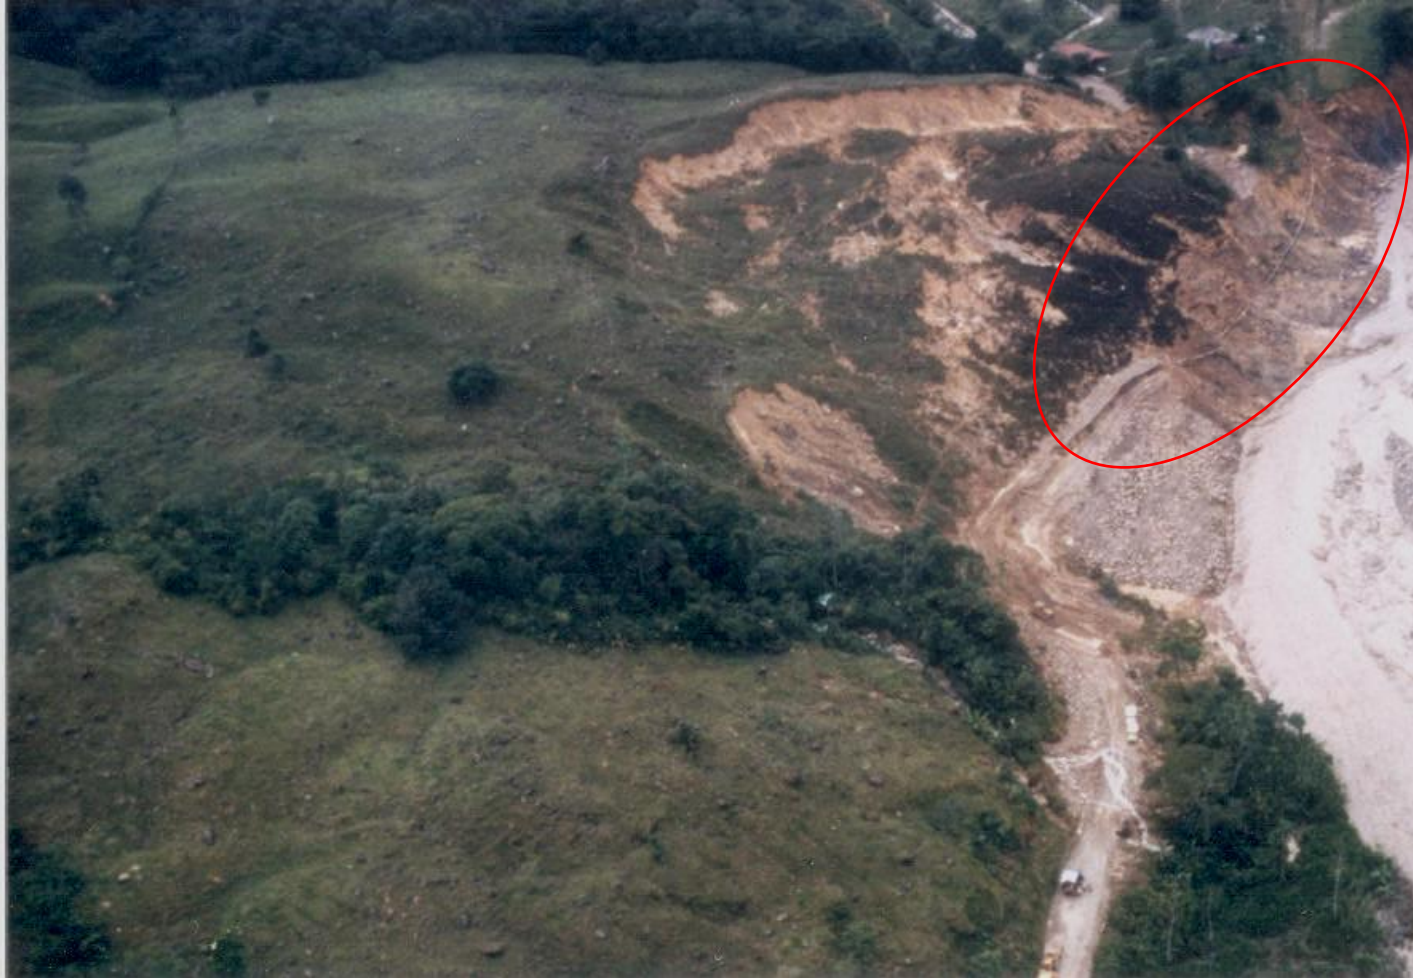
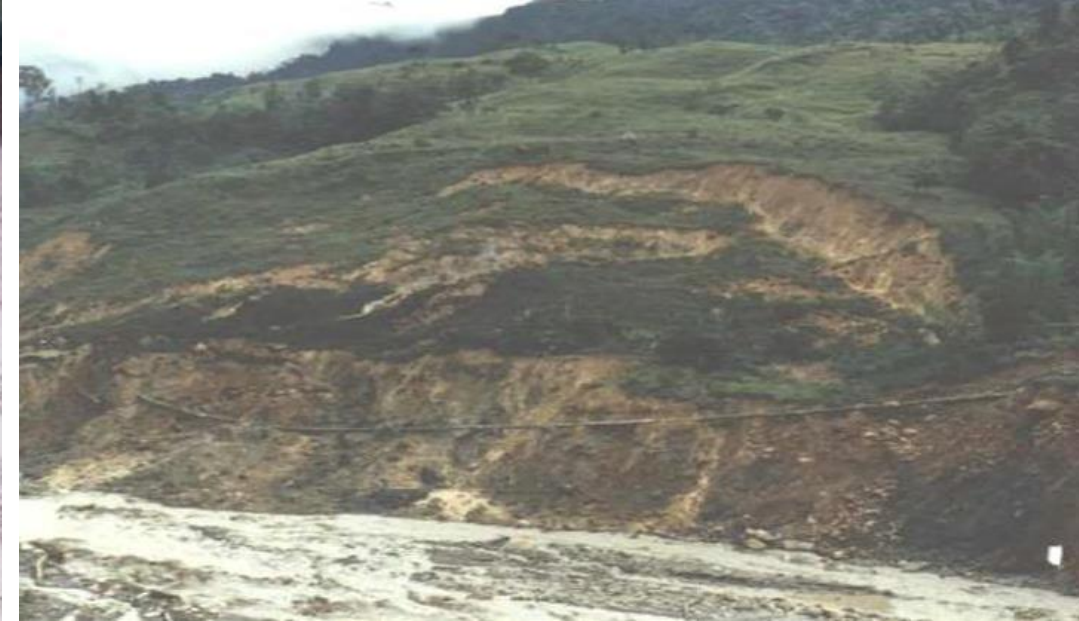
September 14, 1986. Landslide rupture

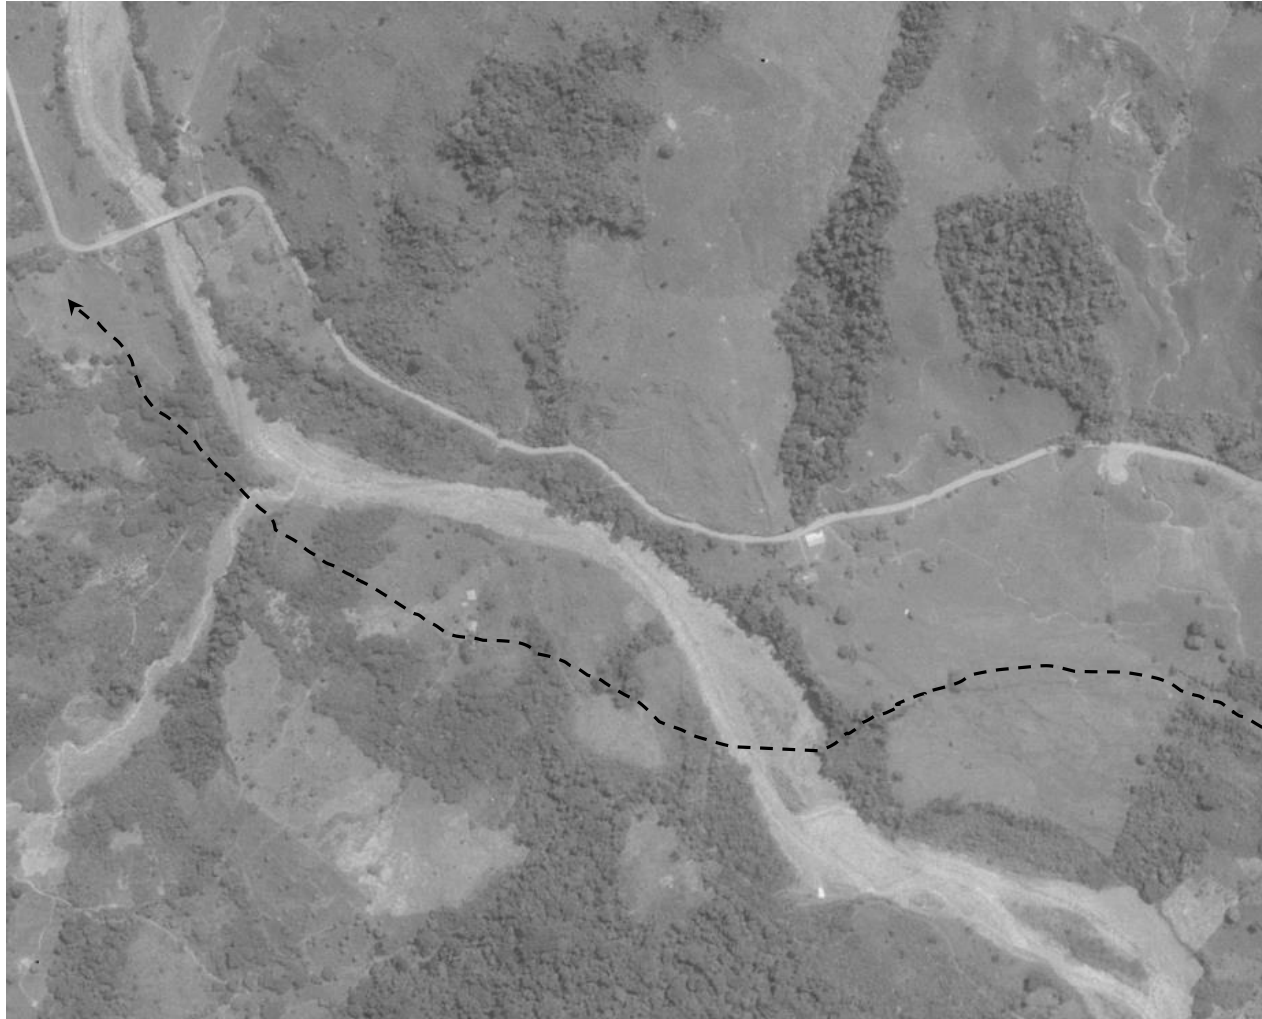
New pipeline centerline after the 1986 landslide.

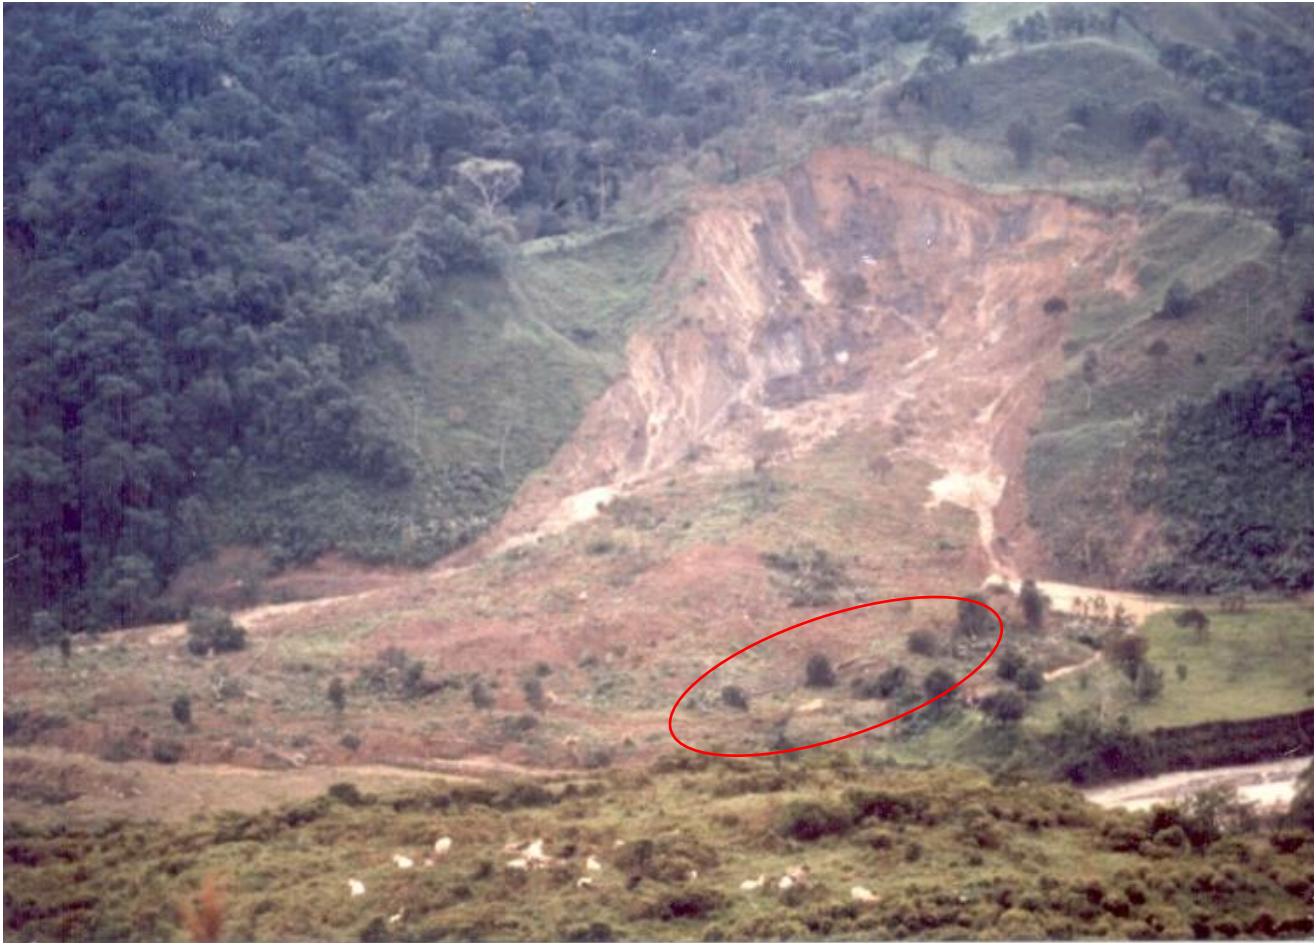
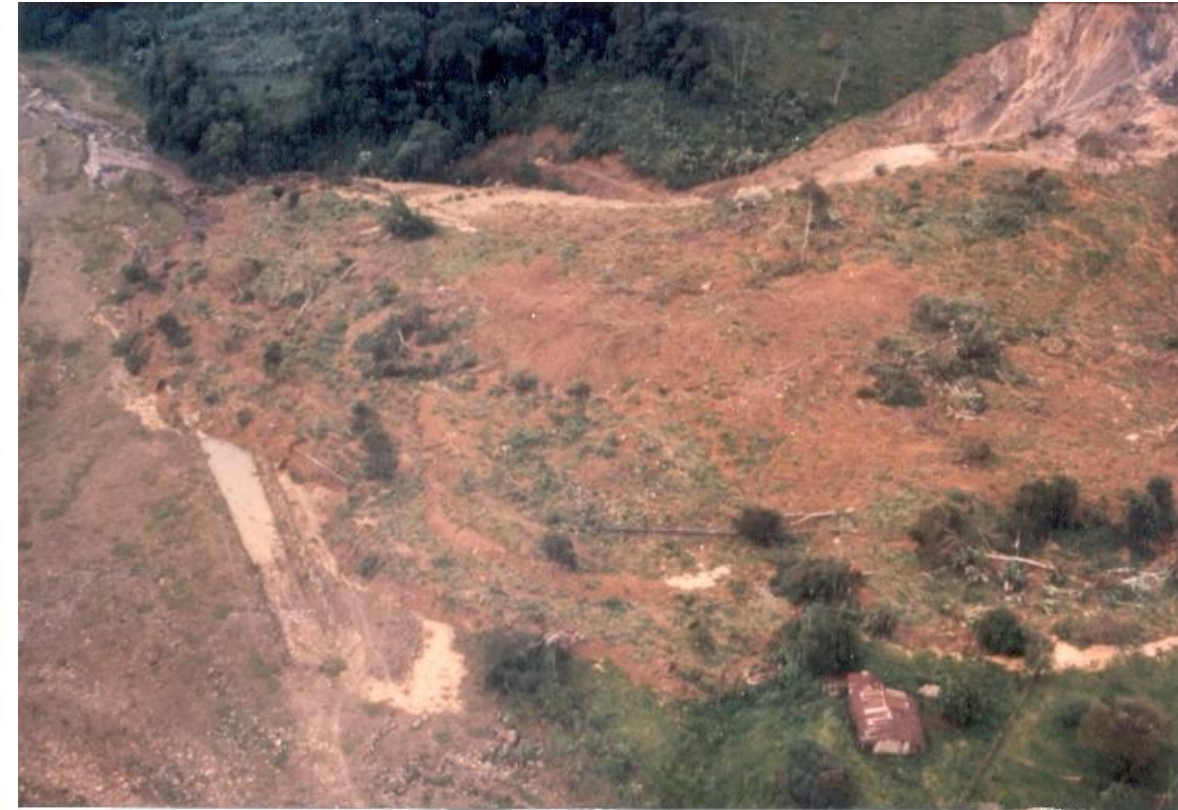
April 25, 1993. New Landslide rupture.

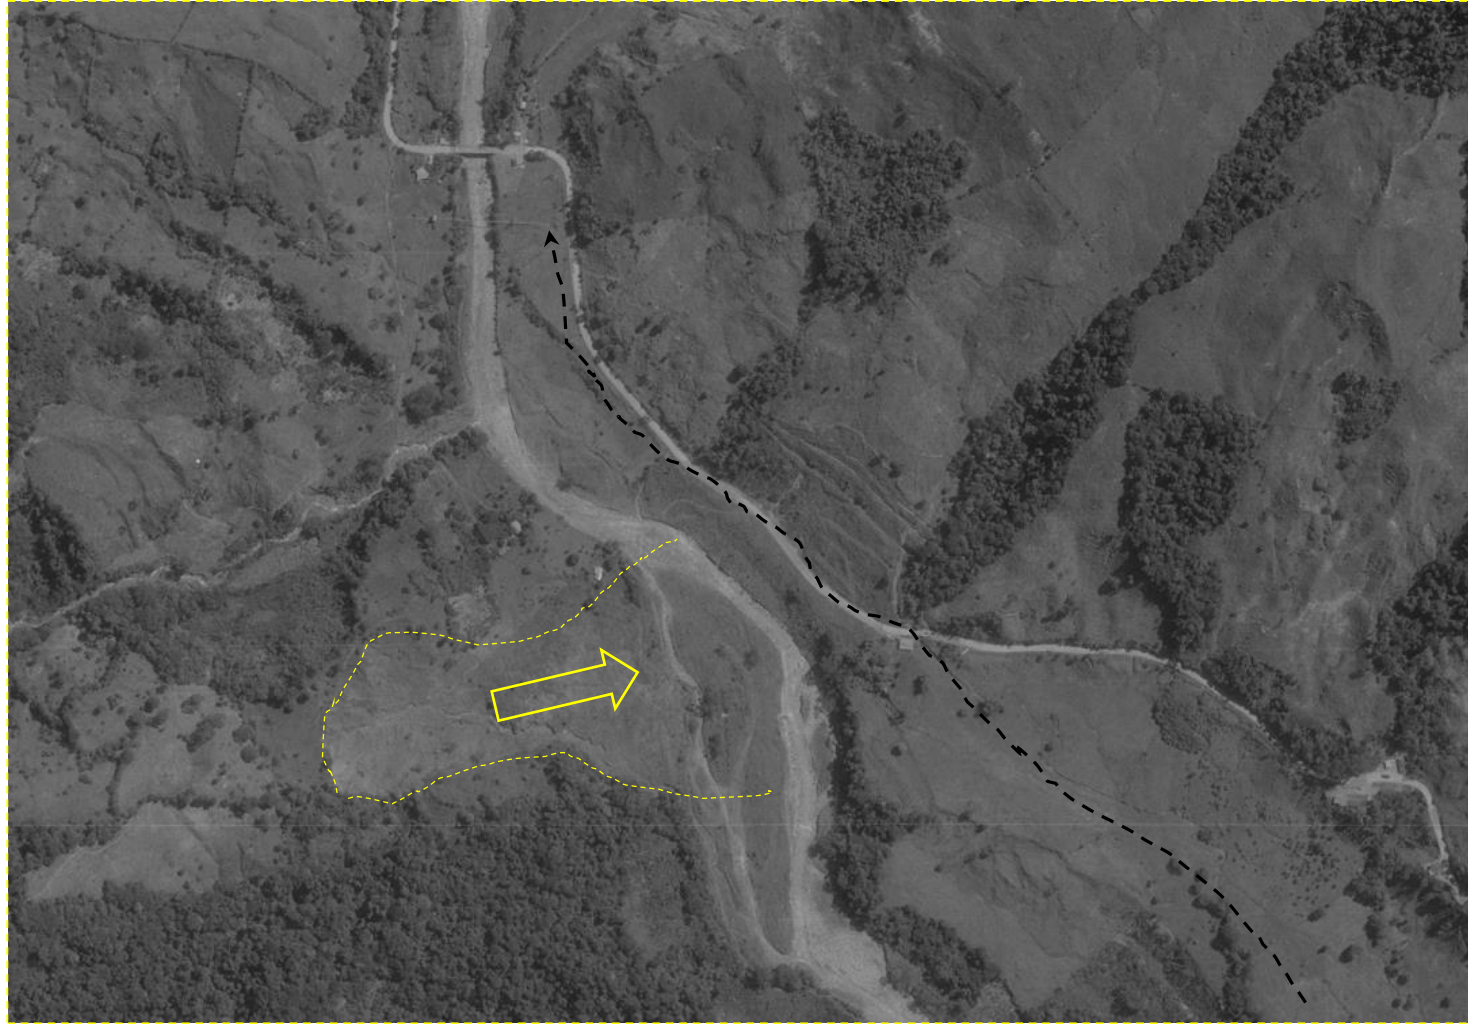
1998 Aerial photography, new pipeline centerline after the event of 1993.

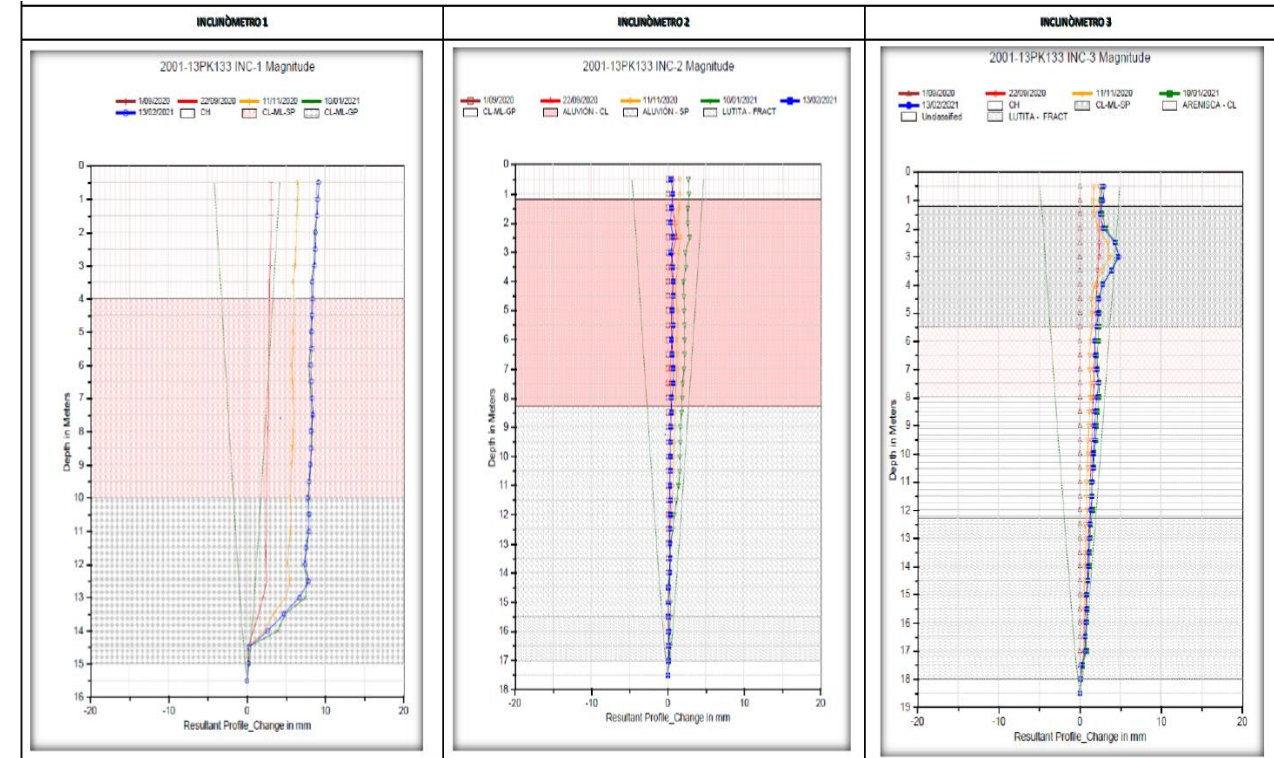
INCLINÓMETRO 1
Dirección: 230 Grad.
Desplazamiento Acum: 9.03 mm
Velocidad Total Acum: 0.055 mm/día
Clasificación Velocidad Relativa: Muy lenta
Superficie de falla: 12.0 m a 14.0 m

INCLINÓMETRO 2
Dirección: 259 Grad.
Desplazamiento Acum: 0.63 mm
Velocidad Total Acum: 0.004 mm/día
Clasificación Velocidad Relativa: Extremadamente lenta
Superficie de falla: N.A.

INCLINÓMETRO 3
Dirección: 252 Grad.
Desplazamiento Acum: 4.82 mm
Velocidad Total Acum: 0.029 mm/día
Clasificación Velocidad Relativa: Extremadamente lenta
Superficie de falla: N.A.

Prior to the event a slope indicator located upslope of the ROW had shown displacements of about 9 mm in the last six months with a failure surface located at 13 m depth. The slope indicators located on the ROW showed no activity.

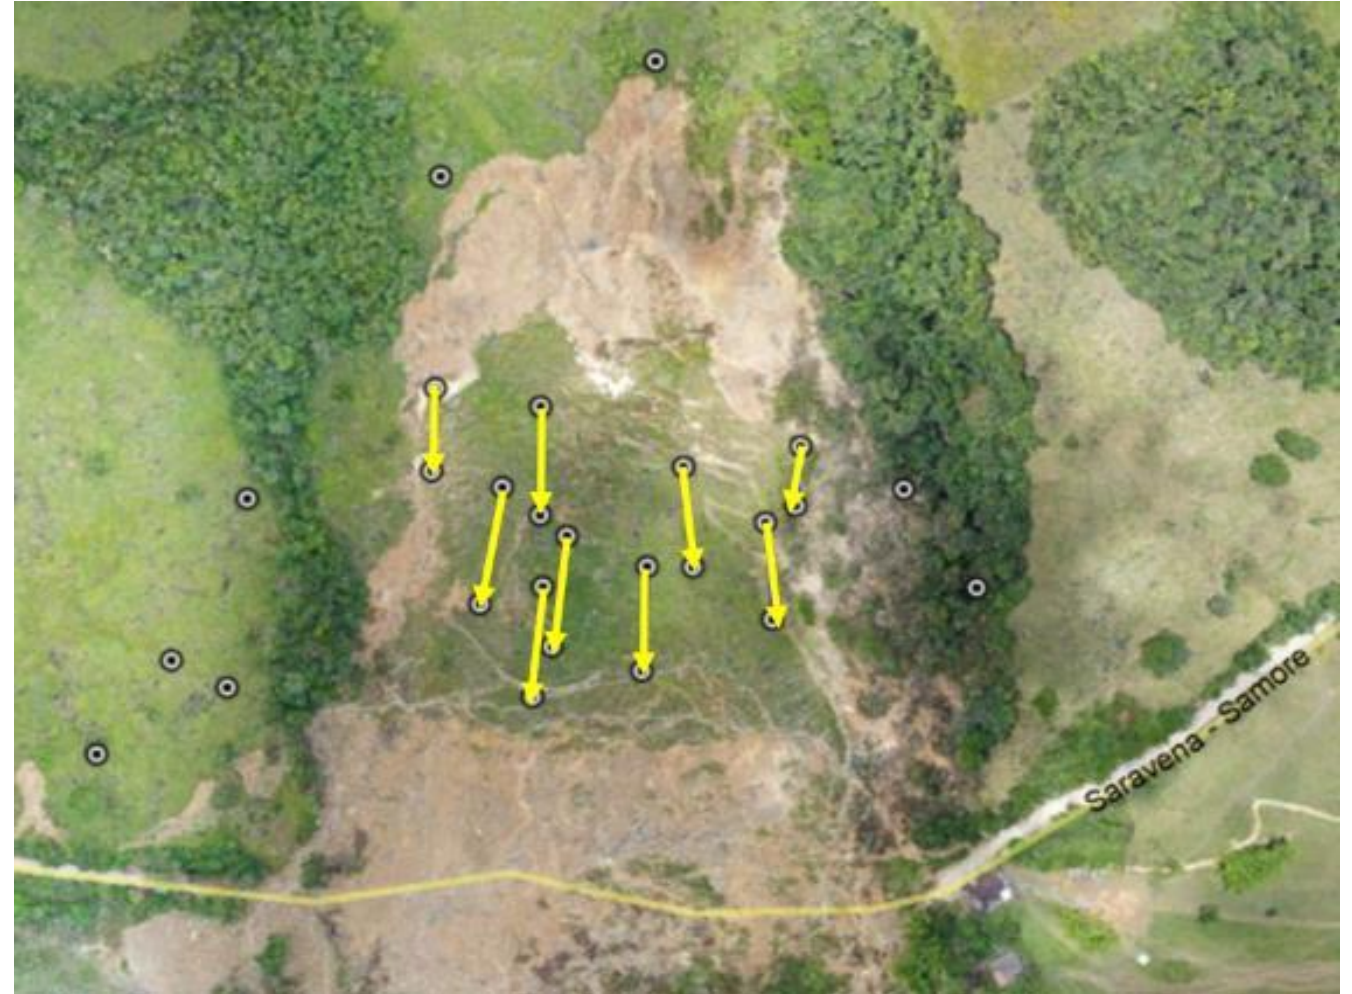
Landslide displacement vectors obtained from multitemporal analysis of orthophotos. it was determined that middle and upper parts of the landslide largely retain their shape, despite the displacements evidenced of about 45 m.

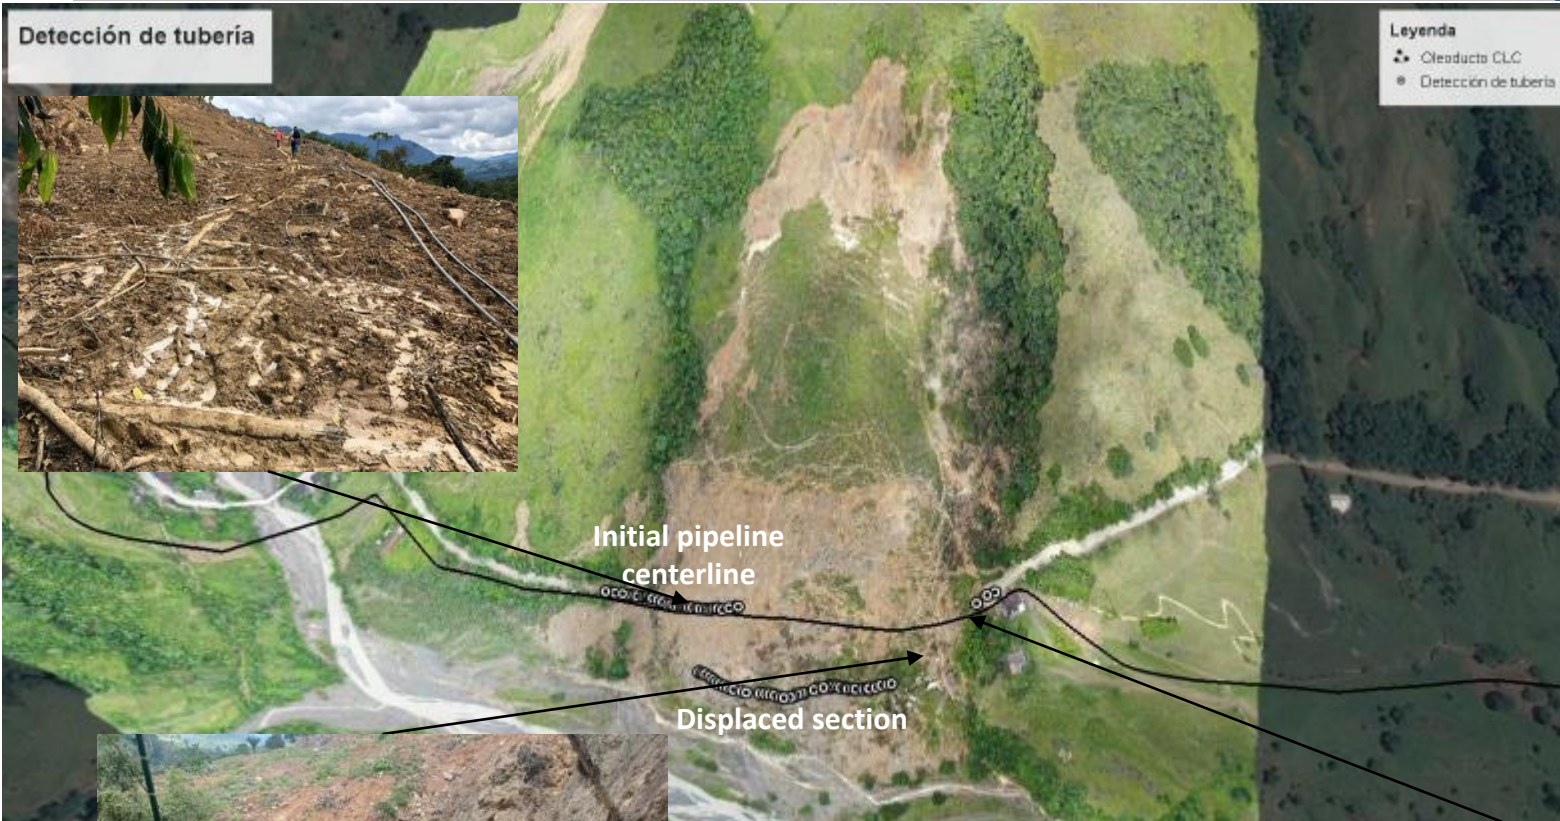
Landslide toe was completely saturated and had a very soft consistency that prevented transit of people and/or equipment.

It was determined that pipeline presented a double break leaving a central section of 173 m that moved about 45 m, confirming the magnitude of the displacement vector.

It was necessary to build a palisade to allow pipeline detection and identify section affected;
