IPG 2025-#00--

## "GEOTECHNICAL PROTECTIONS IN RIVER CROSSING, PK 20,500 PUESTO HERNÁNDEZ - LUJÁN DE CUYO - ARGENTINA OIL PIPELINE"

Leandro Ivorra<sup>1-2</sup>

1 Operational Inspection Analyst – Geotechnical Engineer – YPF SA, La Plata, Argentina.

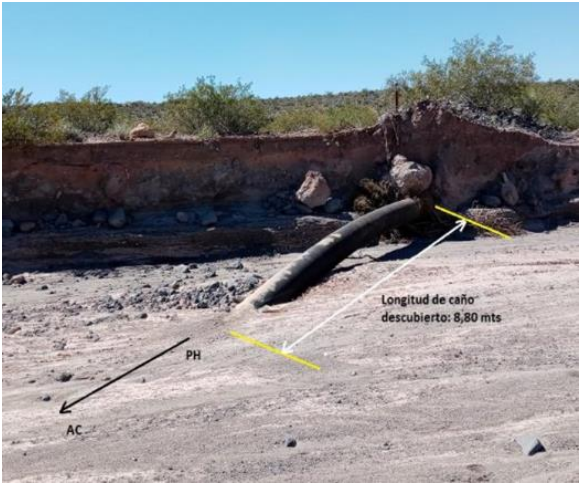
On a tour carried out during the month of February 2021, field personnel detected, after a series of heavy rains in the area, the pipeline completely exposed at Pk 20,510. A length of 8.80 meters of exposed pipe is observed.

FIGURE 2 – Exposed pipeline – Source: Author of the paper

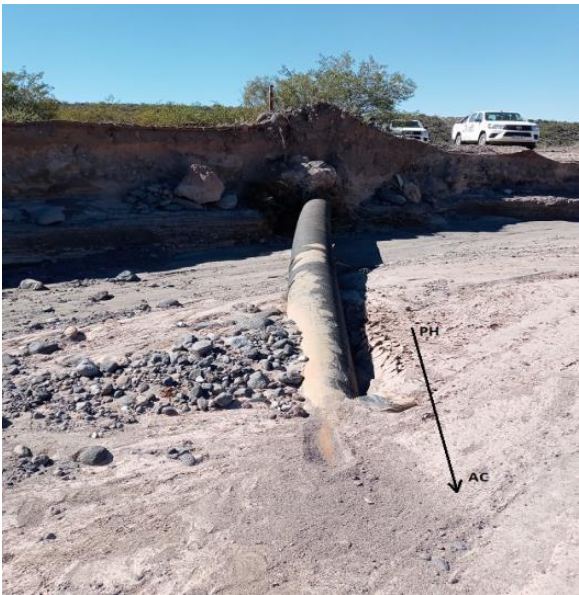
FIGURE 3 – Exposed pipeline – Source: Author of the paper

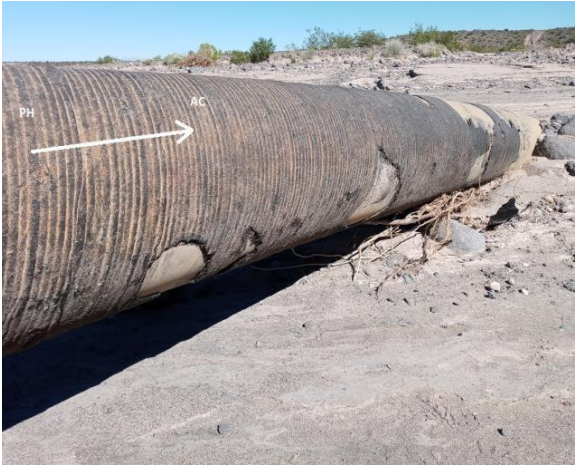
FIGURE 4 – Damage caused – Source: Author of the paper

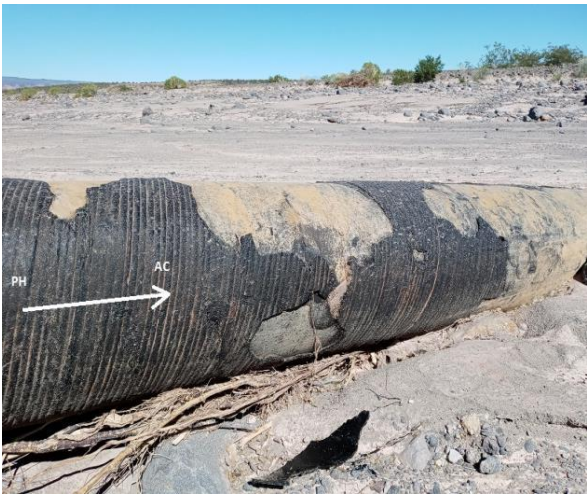
FIGURE 5 – Damage caused – Source: Author of the paper

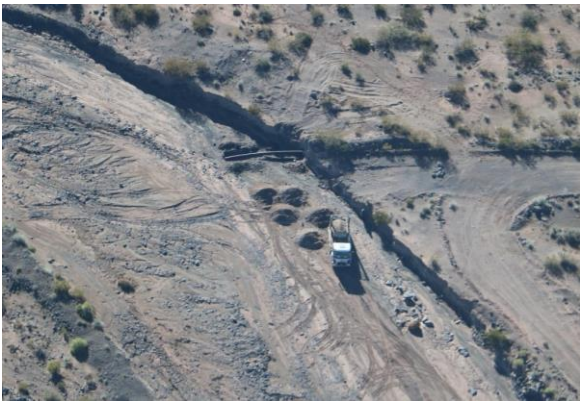
FIGURE 6 – Aerial view of exposed pipeline – Source: Aerial patrol

In this position there was previously a protective work that had been completely destroyed by the meteorological event. (On many occasions, geotechnical protection works must be a "fuse" that acts as such in order to protect the pipeline so that the damage to it is as little as possible).

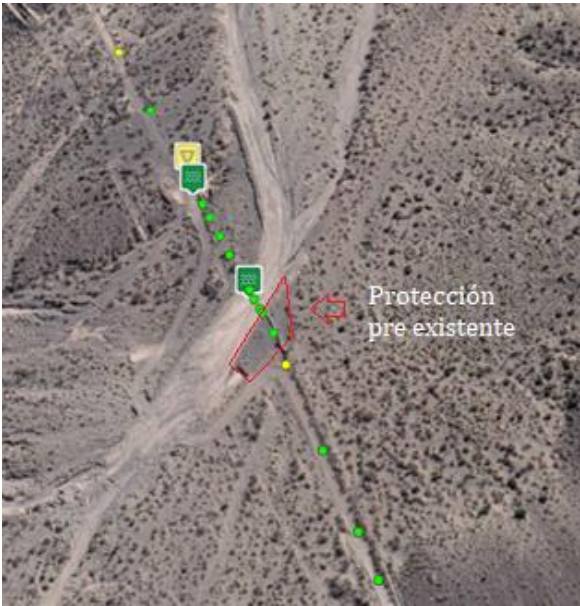
**FIGURE 7** – Location of pre-existing protections. – Source: Google Earth

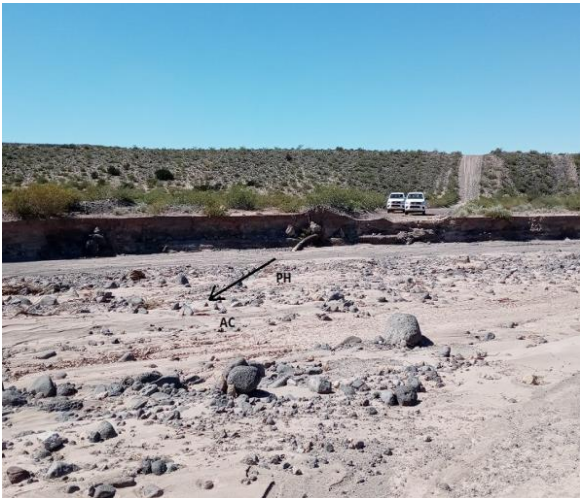
On the other hand, it can be seen that the semi-permanent channel has a significant drag of stones and other blunt elements that are potentially risky for the pipeline, in fact, it was corroborated a posteriori, that the deterioration of the lining and the dents found were due to the impact of the transported elements.

**FIGURE 8** – general view of the affected area – Source: Author of the paper

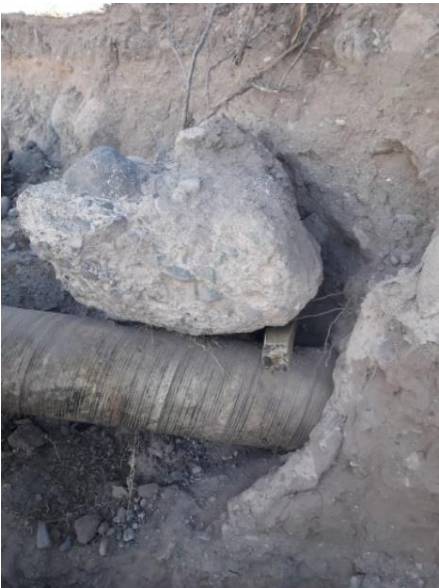
**FIGURE 9** - Stone on the pipeline after the event - Source: Author of the paper

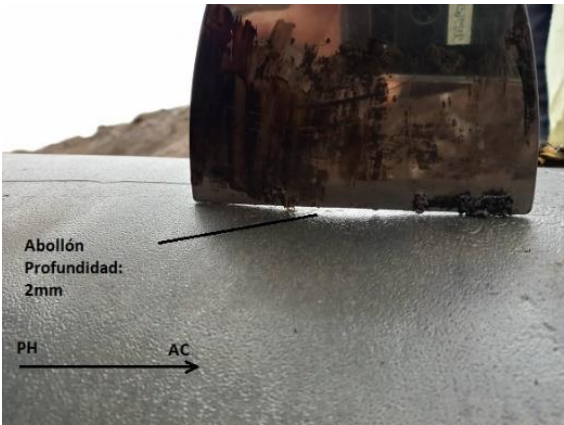
The first step was to perform a visual inspection of the pipeline for cracks or dents. Fortunately, the mechanical integrity of the line remained unchanged, but dents were found due to impacts.

**FIGURE 10** – damage assessment. – Source: Athor of the paper

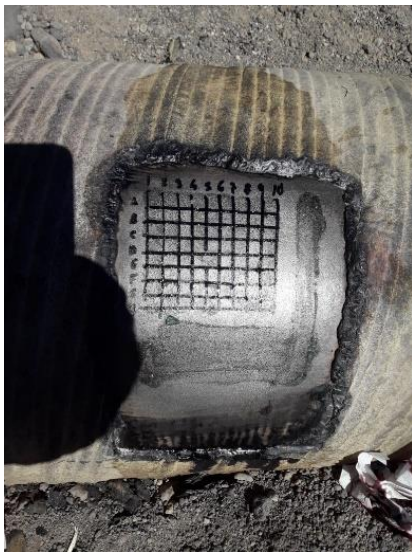
**FIGURE 11** – pipeline damage assessment – Source: Author of the paper

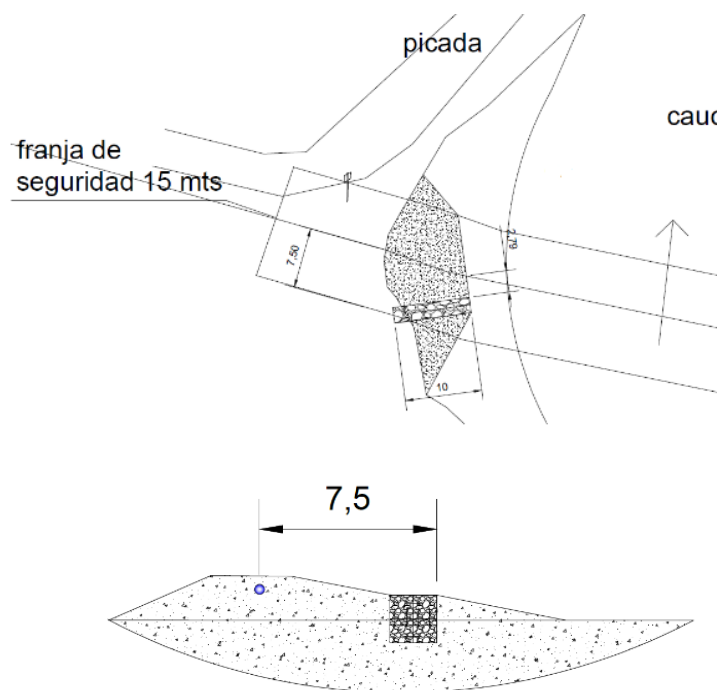
**FIGURE 13** – Provisional work schematic plan –  
Source: Author of the paper

Due to the fact that the final work was going to take some time to carry out due to logistics and other operational issues, a first provisional protection was materialized, which consisted of making two small breakwaters of 10 meters in length with gabions and the accumulation of fine soil on the duct. First, the south gabion row was made and then completed as shown in FIG.14. After these tasks, the pipeline obtained a plug of approximately 0.80 meters.

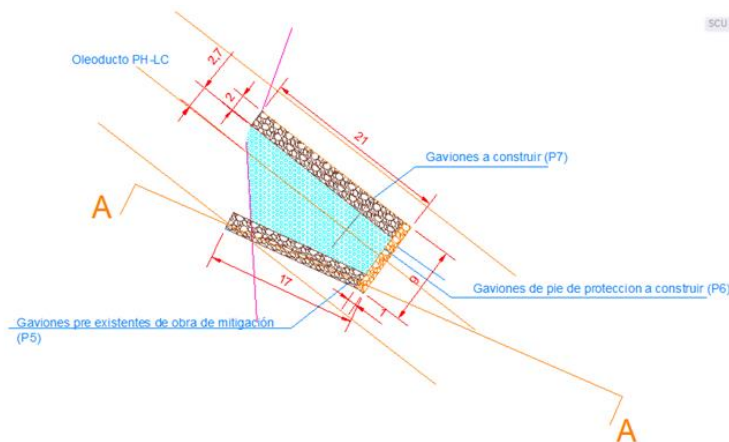
**FIGURE 14** – Schematic plan of the final provisional work – Source: Author of the paper

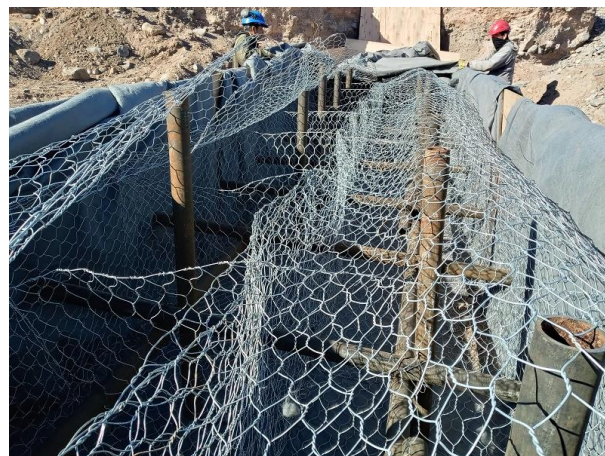
**FIGURE 15** – Construction of temporary work with gabions and reinforcement tubing – Source: Author of the paper

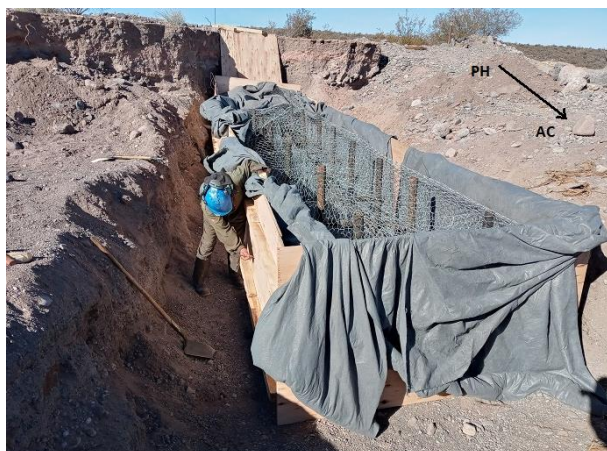
**FIGURE 16** – Construction of temporary work with gabions and reinforcement tubing – Source: Author of the paper

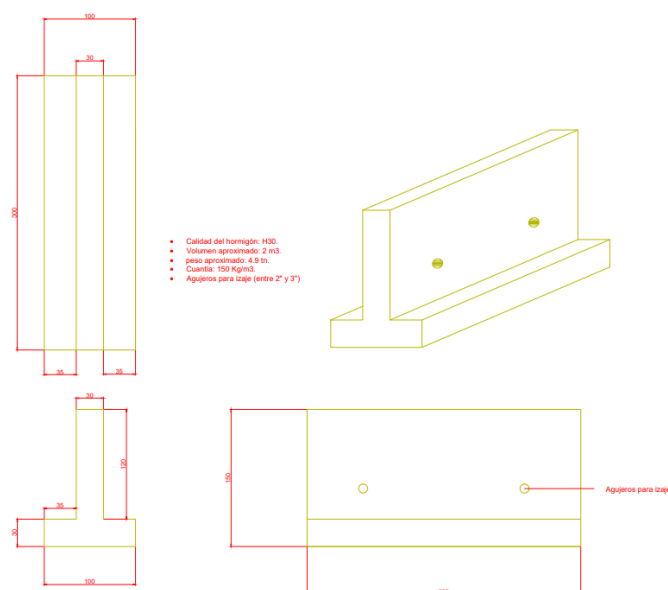
**FIGURE 17** -Sleepers Plans – Source: Author of the paper

The materialization of the breakwaters was originally thought to be made using large stone blocks present in the place. As this was not possible, it was decided to make them with sleeper concrete blocks, which were detailed in FIGs 17 and 18

Once the solution had been chosen, it was necessary to study what material to make it with. This was limited to two options, which was to use large rocks similar to those used at sea or to use pre-cast elements of great weight and volume. Finally, he opted for the latter, which had to be manufactured so they had to be as robust and simple as possible. They were designed, calculated and sent to be built more than 400 km from the construction site.

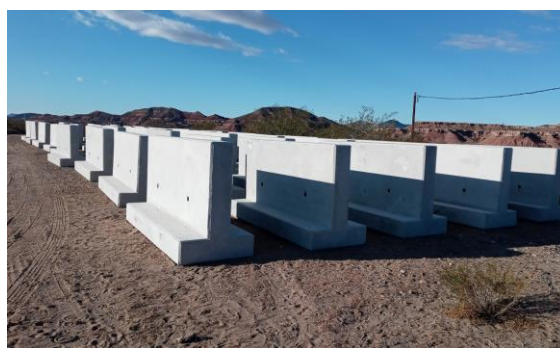
**FIGURE 18** – On-site sleepers – Source: Author of the paper

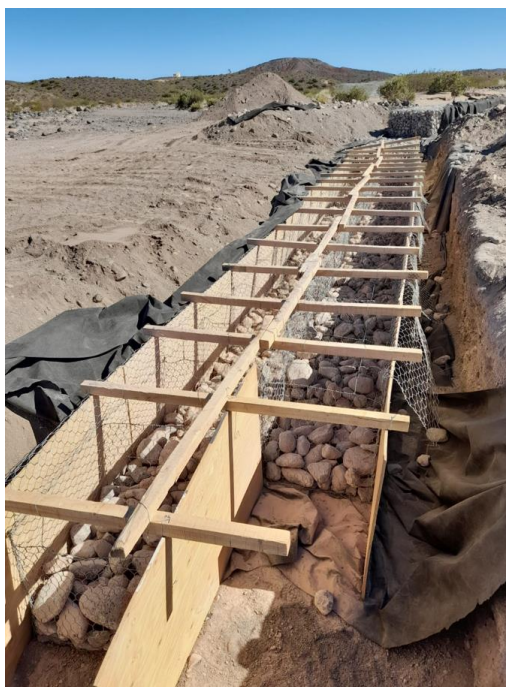
**FIGURE 20** – Construction of foot protections to prevent undermining - Source: Author of the paper

The construction process consisted of first making foot protections to prevent the washing of fines. This was done using gabions buried below the sleepers' line as seen in FIG 20

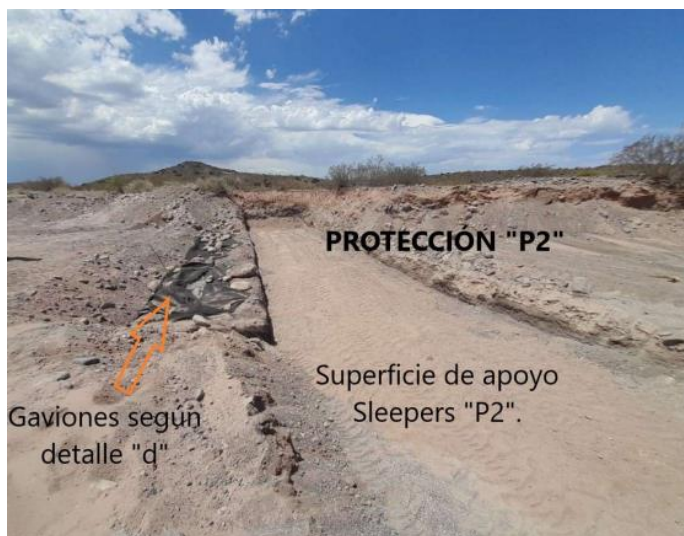
**FIGURE 21** – Preparation of inclined surface for the placement of sleepers - Source: Author of the paper

These tasks have been accomplished. The support base of the sleepers was compacted, giving it a slope such that at its end what protruded from the ground was 1.00 m. (see FIG. 26)

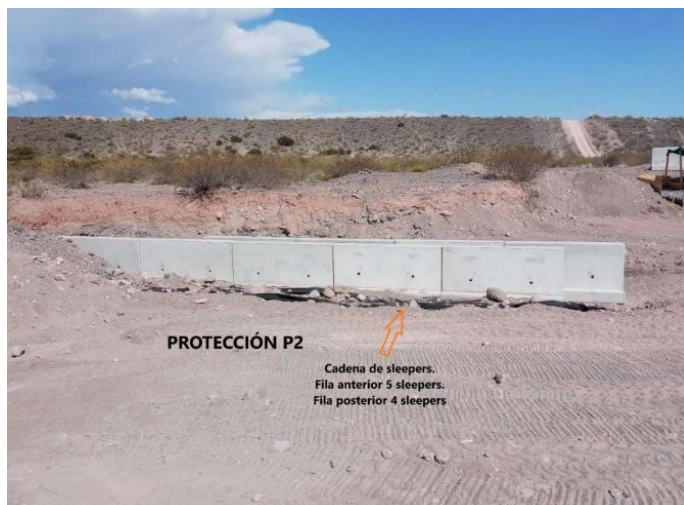
**FIGURE 22** – Sleepers in final position - Source: Author of the paper

The concrete blocks were arranged in double rows (FIG. 26) to increase their strength and stability, also contemplating foot protections to prevent erosion, as mentioned above, and placing a fill of soil from the place in the space between them.

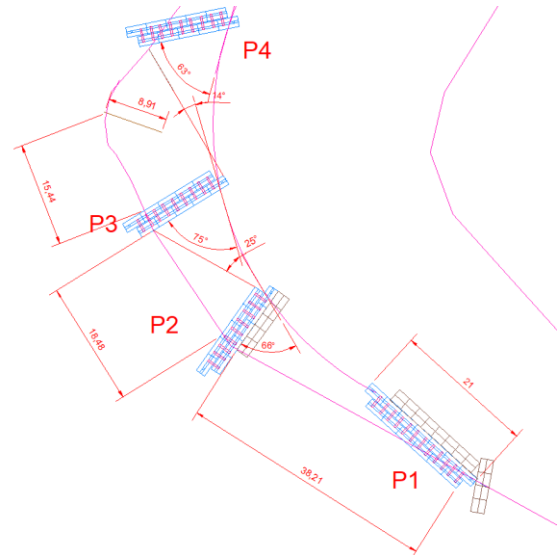
**FIGURE 24** – General implementation of protections with  
indication of main angles and distances - Source: Autor of the  
paper

The breakwaters were calculated by determining restitution angles with respect to the tangent of the eroded bank of approximately 60° to 70° and taking care that the tip of these did not form erosion pots that could affect the riverbed.

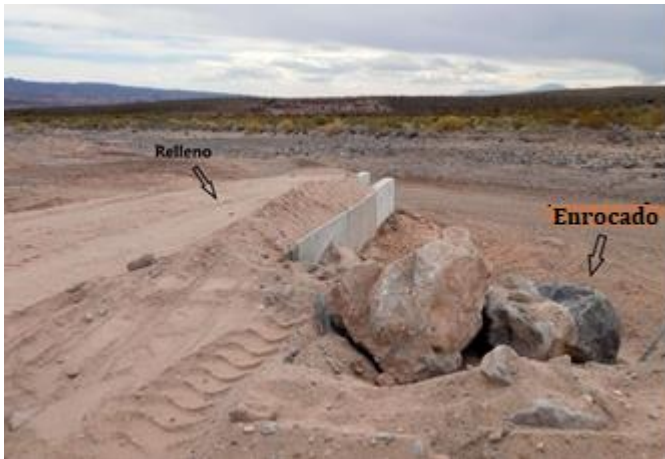
**FIGURE 27** – Materialization of erosion protection rocks -  
Source: Author of the paper

At the meeting between the slope and the P2, P3 and P4 protections, an erosion protection rockwall composed of stones of approximately 0.20 m<sup>3</sup> must be placed, previously placing a geotextile (only on the upstream side)

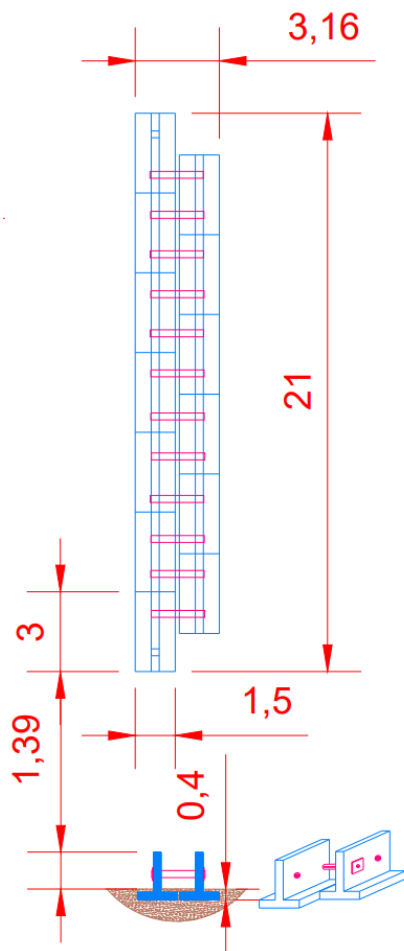
**FIGURE 28** – Construction details – Riprap plant and foot protections - Source: YPF SA

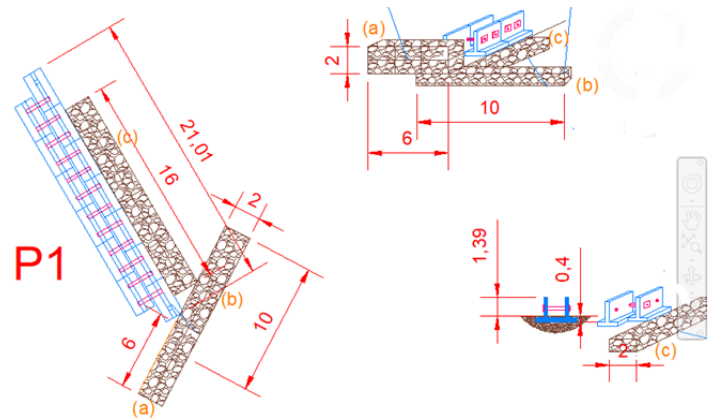
**FIGURE 29** – Plan Details - Foot Erosion Protection –  
Source: YPF SA

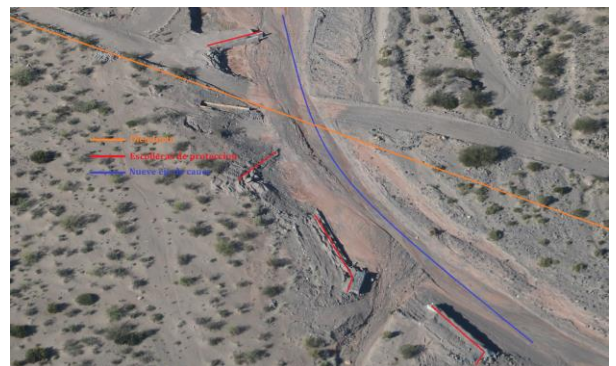
The riverbed has been backed on the north bank as planned and there have been no relevant developments at the moment.

**FIGURE 30** – Aerial view of completed work 1 –  
Source: Aerial patrol

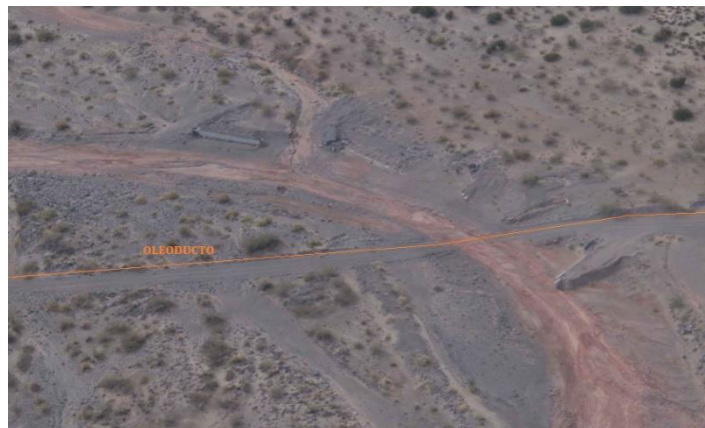
The protections put in place have more than served their purpose. The original intention was that these breakwaters would be covered little by little, by the soil of the place, something that is beginning to be fulfilled, more than two years after its completion.

**FIGURE 33** - Aerial view of completed work with relative location of the pipeline - Source: Aereal patrol
