## IPG 2023-#0011

### "GEOTECHNICAL PROTECTIONS IN RIVER CROSSING, PK 20,500 PUESTO HERNÁNDEZ - LUJÁN DE CUYO - ARGENTINA OIL PIPELINE"

Leandro Ivorra<sup>1-2</sup>

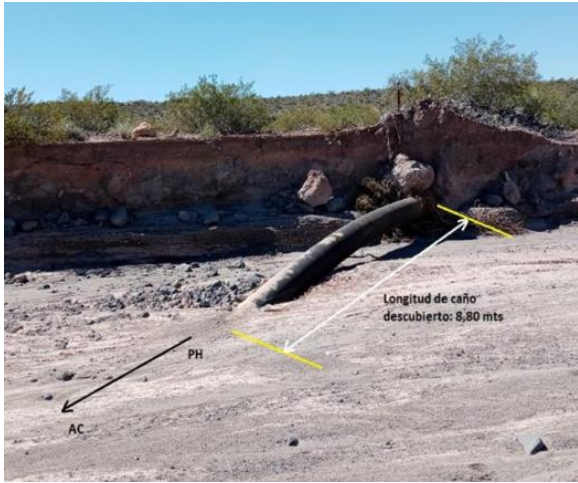
On a tour carried out during the month of February 2021, field personnel detected, after a series of heavy rains in the area, the pipeline completely exposed at Pk 20,510. A length of 8.80 meters of exposed pipe is observed, of which about 4.40 meters had serious flaws in its lining.

FIGURE 2 – Exposed pipeline– Source: YPF SA

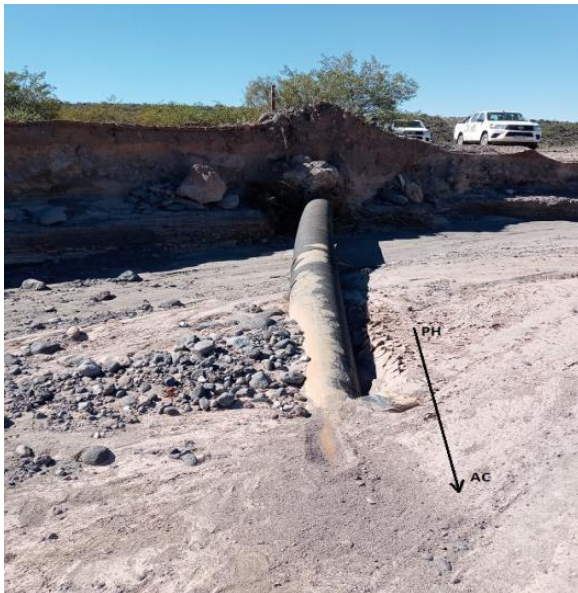
FIGURE 3 – Exposed pipeline– Source: YPF SA

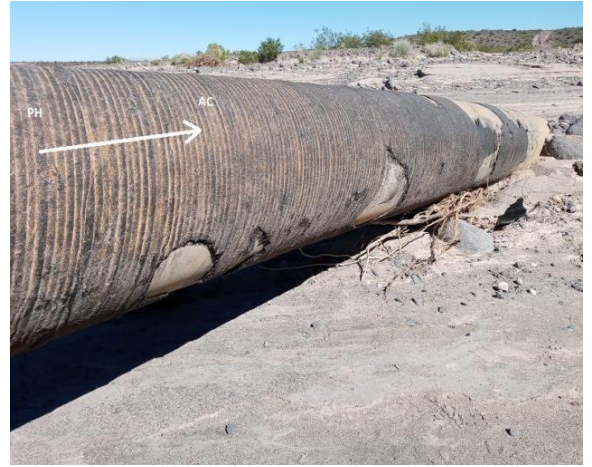
The preceding figures show the state of the situation in the area, highlighting severe damage to the lining of the pipeline as a result of the violent impacts received.

FIGURE 4 – Damage caused – Source: YPF SA

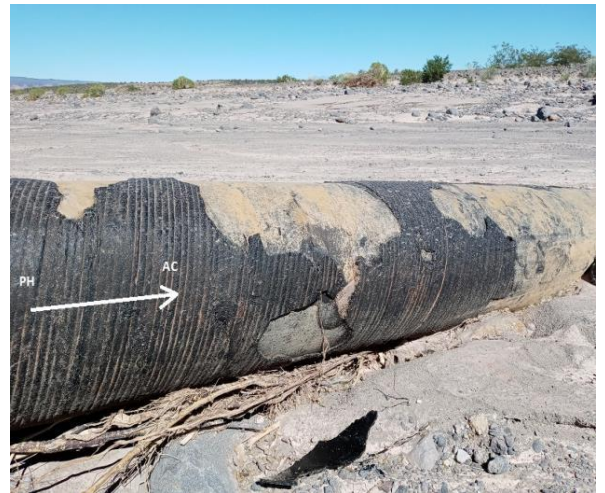
FIGURE 5 – Damage caused – Source: YPF SA

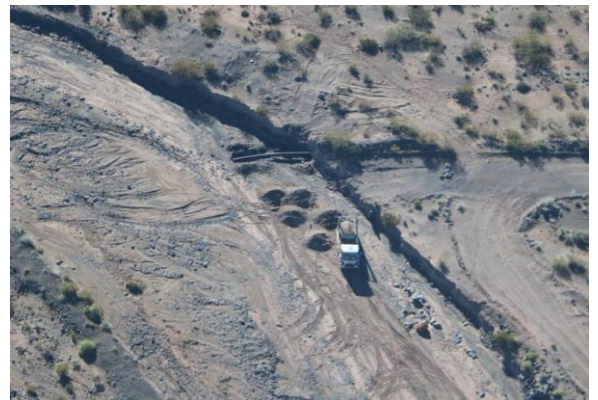
FIGURE 6 – Aerial view of exposed pipeline – Source: YPF SA

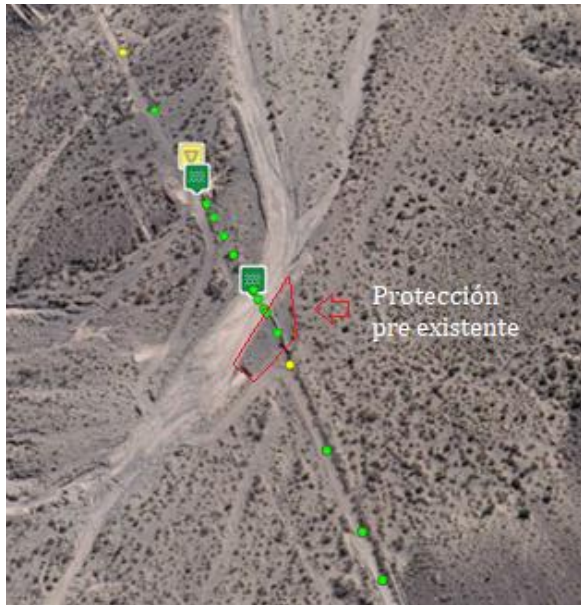
In this position there was previously a protective work that had been completely destroyed by the meteorological event. (On many occasions, geotechnical protection works must be a

"fuse" that acts as such in order to protect the pipeline so that the damage to it is as little as possible).

**FIGURE 7** – Location of pre-existing protections. – Source: YPF SA

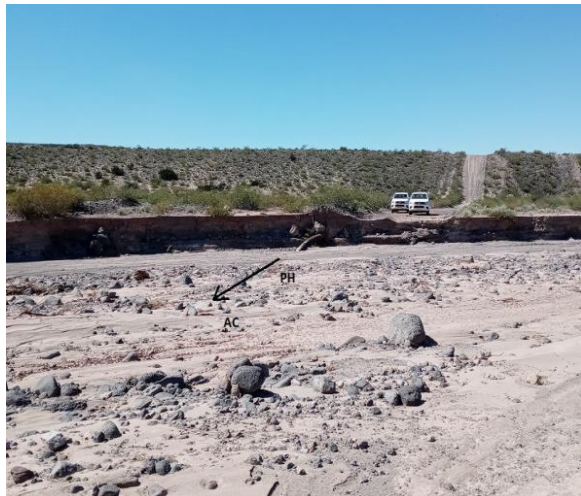
On the other hand, it can be seen that the semi-permanent channel has a significant drag of stones and other blunt elements that are potentially risky for the pipeline, in fact, it was corroborated a posteriori, that the deterioration of the lining and the dents found were due to the impact of the transported elements.

**FIGURE 8** – general view of the affected area – Source: YPF SA

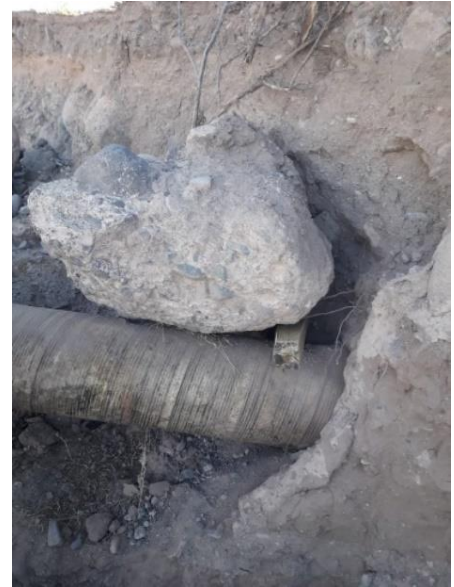
**FIGURE 9** - Stone on the pipeline after the event - Source: YPF SA

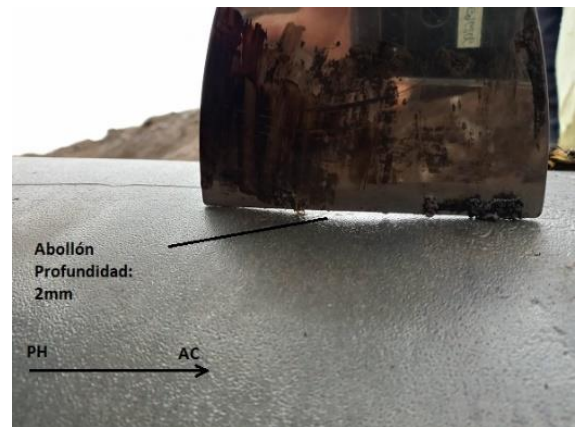
The first step was to perform a visual inspection of the pipeline for cracks or dents. Fortunately, the mechanical integrity of the line remained unchanged, but dents were found due to impacts.

**FIGURE 10** – damage assessment. – Source: YPF SA

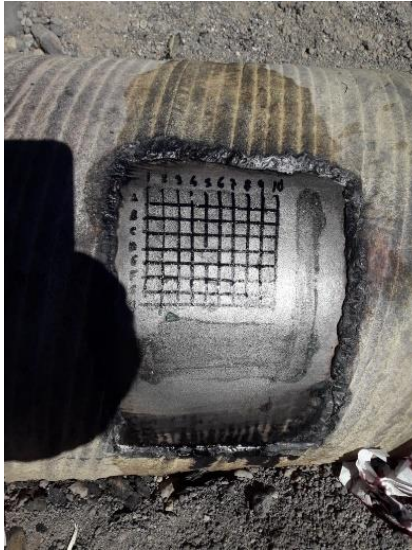
FIGURE 11 – pipeline damage assessment– Source: YPF SA

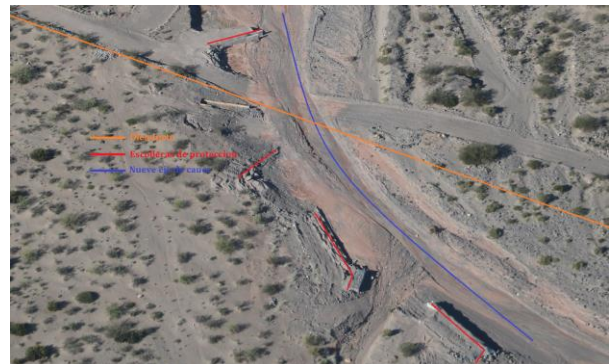
The riverbed has been backed on the north bank as planned and there have been no relevant developments at the moment.

**FIGURE 30** – Aerial view of completed work 1 – Source: YPF SA

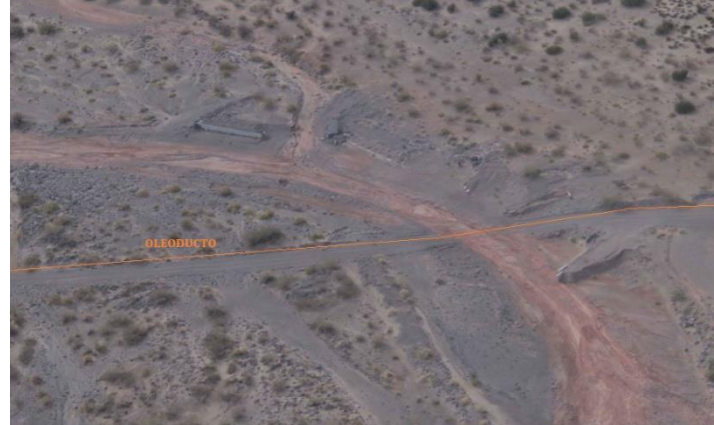
The protections put in place have more than served their purpose. The original intention was that these breakwaters would be covered little by little, by the soil of the place, something that is beginning to be fulfilled, more than two years after its completion.

**FIGURE 33** - Aerial view of completed work with relative location of the pipeline - Source: YPF SA
