RIVERSIDE DEFENSE AND RECOVERY OF THE RIGHTH OF WAY AT 563.3 KILOMETER OF SECTION II OF THE NORTH PERUVIAN PIPELINE

Arevalo Saavedra César Horacio¹, Díaz Llanos Juan Alberto¹, Yparraguirre Olano Mayco Wrayan¹, Zeña Sandoval José Antony¹

¹ PETROPERÚ, Petróleos Del Perú

6TH INTERNATIONAL PIPELINE GEOTECHNICAL CONFERENCE IPG 2023

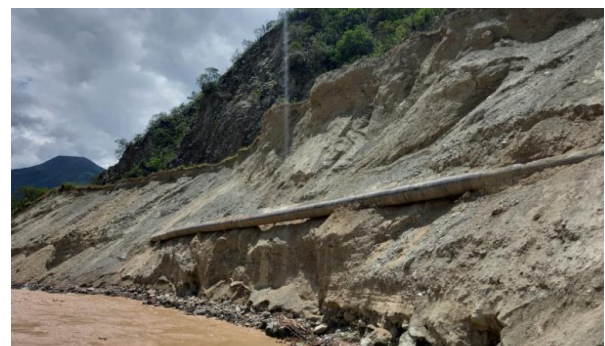
FIGURE 2: SECTOR 1 OF 58 METERS OF 36" PIPE WAS FULLY EXPOSED.

The erosion produced at Km 563.3 ONP, has generated the following emergency conditions and immediate attention: Erosion-disappearance of the slope of the ROW approximately 330 m in length; Discovery of the 92 m long pipeline, leaving it exposed to a risk of rupture; accelerated eroding process that has been activated downstream of the last eroded point, of approximately 320 m, which compromises the ROW of the ONP; and instability of the asphalt layer in the upper part of the eroded slope, which is the natural access to the various ONP pumping stations.

As a solution to the problems described above, the restitution of the ROW has been considered, through the construction of 753 m of river defense made up of riprap, riprap and fill material, in addition to the construction of a base terrace on the crown of the riprap. This solution intends to divert the waters to avoid the collapse of the eroded slope, protect the eroded slope, and restore the eroded ROW.

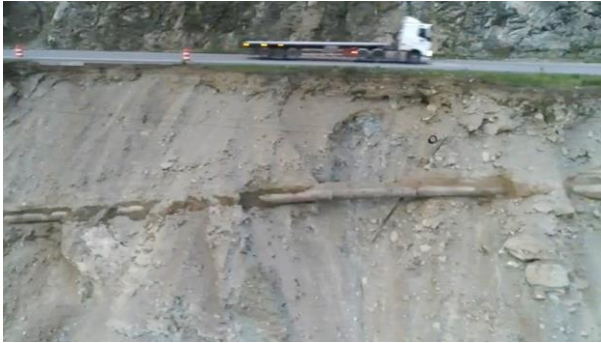
FIGURE 3: SECTOR 2 OF 41 METERS OF 36” PIPE WAS FULLY EXPOSED.

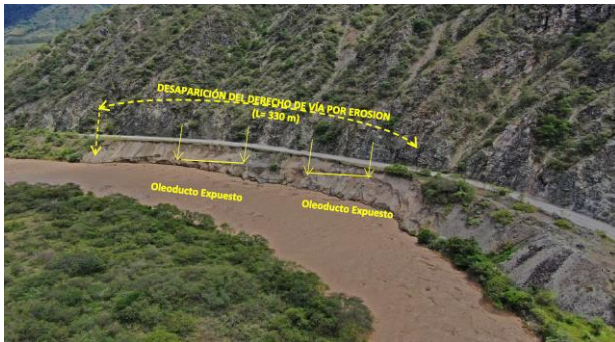
FIGURE 4: EROSIVO PROCESS THAT GENERATED THE DISPLACEMENT OF THE CHAMAYA RIVER BED TOWARDS ITS RIGTH SIDE, AFFECTING THE RIGTH OF WAY OF THE ONP.

The eroded slope (right side of the Chamaya river) is made up of alluvial material (GM), corresponding to a combination of the natural slope and the cut material deposited during the construction of a section of highway (Fernando Belaunde Terry highway or marginal from the jungle). Due to the characteristics of the matrix, the slope is erodible in the presence of water flow.

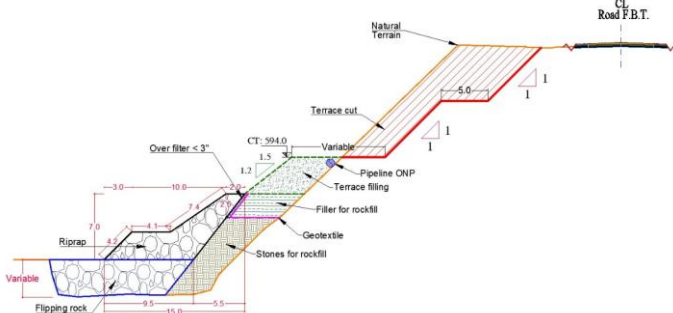
FIGURE 8: TYPICAL RIPRAP SECTION.

With the parameters obtained, the typical section of the built riprap was determined, which allowed the restitution of the right of way. The construction of seven hundred and fifty-three meters (753 m) of river defense, made up of riprap and fill material, in addition to the construction of a base terrace on the crown of the riprap, served multiple purposes:

- i) Divert the water to prevent the collapse of the eroded slope.
- ii) Eroded slope protection.
- iii) Restore the eroded right-of-way (which may allow the construction of a possible variant of the pipeline).

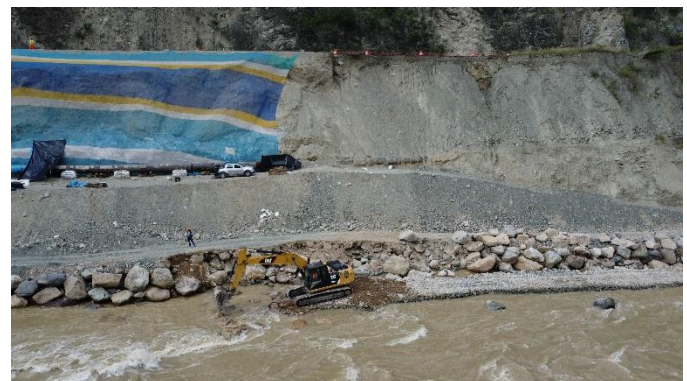
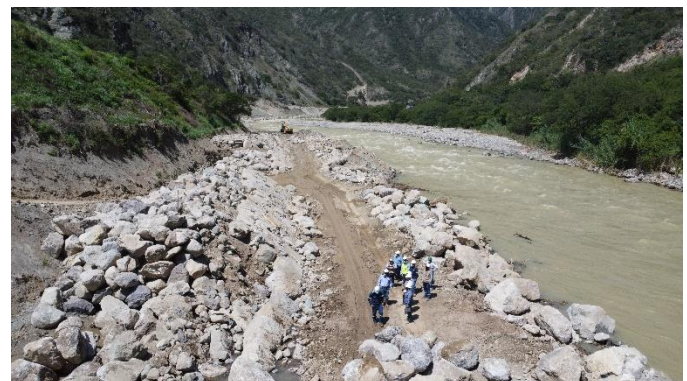
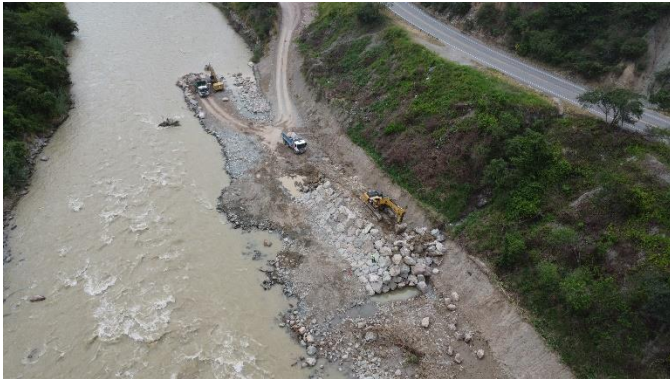
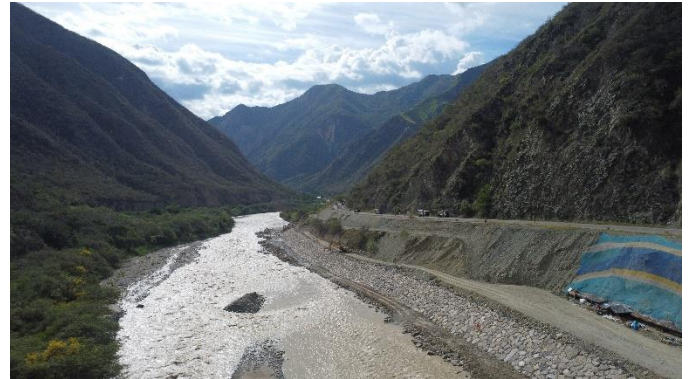
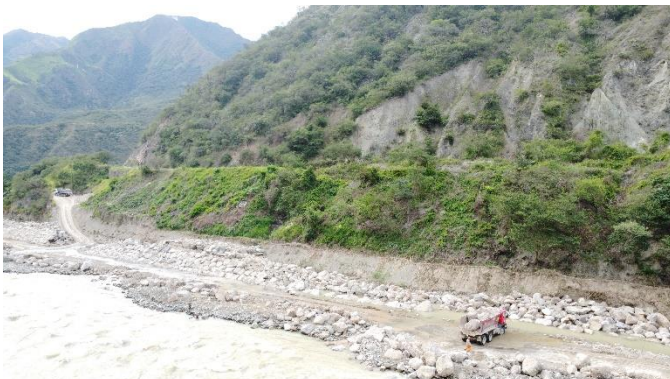
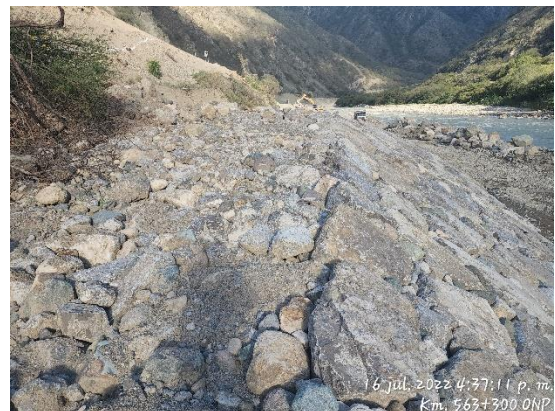
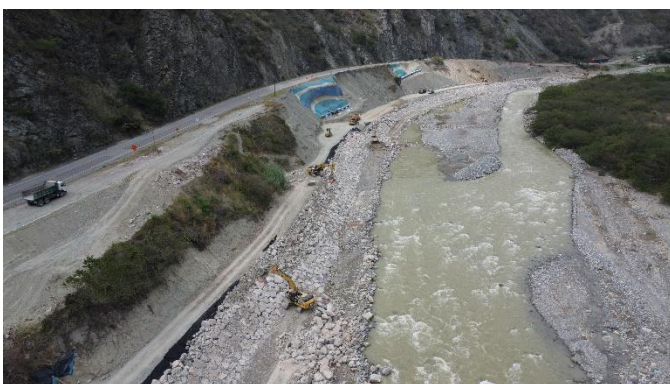
FIGURE 9: CONSTRUCTIVE PROCEDURE OF RIPRAP.

Structure made up of rocks (Dm >1.20m) placed or accommodated with the help of mechanical equipment, which has the purpose of:

The riprap material was obtained from five (05) points located during the initial stage of the Service. The extraction was carried out by blasting and selecting the rock that meets the specified dimensions. The prepared rocks were placed in the toe and slope of the riprap following the geometric dimensions indicated in the respective plans. Due to the restrictions of the work area for the construction process, the slopes of the typical section were worked as aligned as possible, with the variations of the body of the riprap that were generated not less than indicated in the plans. For the interlock of the riprap between the large rocks, rocks of smaller than nominal diameter were used in order to reduce the interstices that form between rock and rock. Special care was taken to reach the crown levels of riprap.

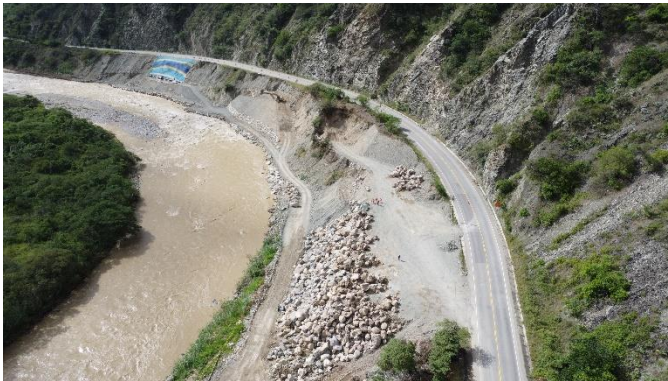
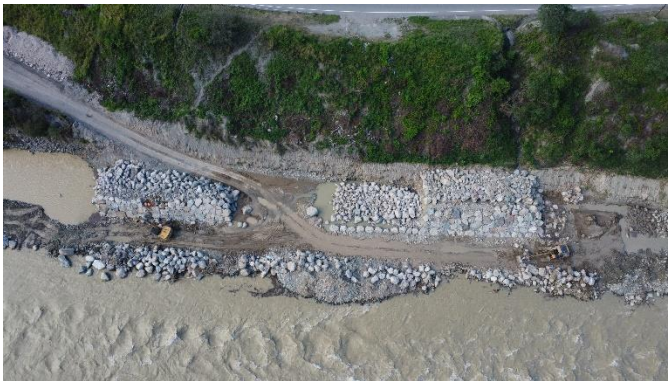
FIGURE 16: ROCKFILL CONSTRUCTIVE PROCEDURE FOR RIPRAP.

Structure made up of rocks ($1.20\text{m} > D_m > 0.70\text{m}$) placed or accommodated with the help of mechanical equipment, which has the purpose of restoring the material between the internal slope of the riprap and the slope of the land after erosion.

The riprap material was obtained from two (02) points located during the initial stage of the Service and the extraction was carried out by selecting the rock that meets the specified dimensions. The prepared rocks were placed between the riprap and the slope of the land after erosion following the geometric dimensions indicated in the respective plans. For the interlock of the causeway between the rocks, rocks of smaller than nominal diameter were used in order to reduce the interstices that form between rock and rock.

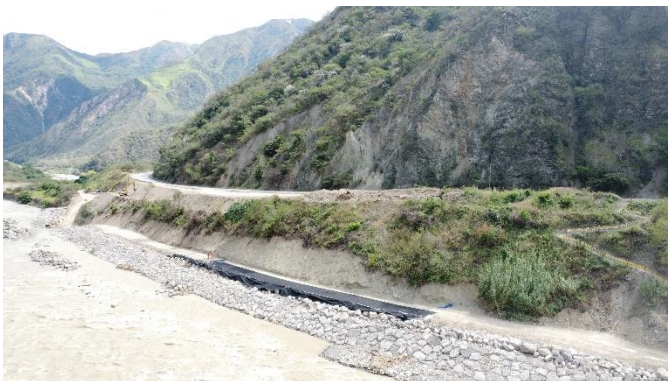
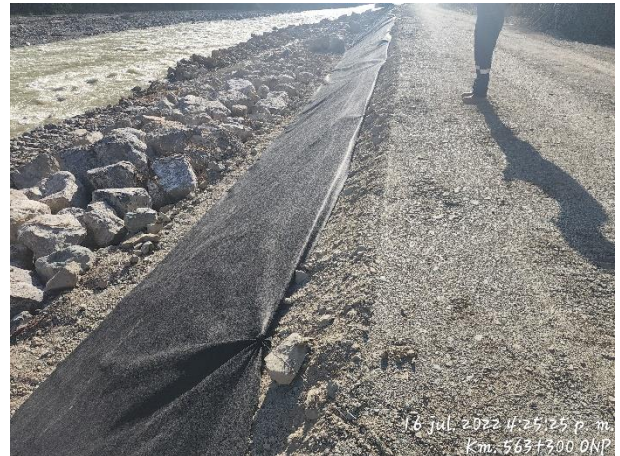
FIGURE 18: CONSTRUCTION PROCEDURE FOR GEOTEXTILE INSTALLATION.

Its arrangement was at the rear of the riprap, with the purpose of controlling the escape of soil fines. The materials to be used can be made of non-woven synthetic polymers.

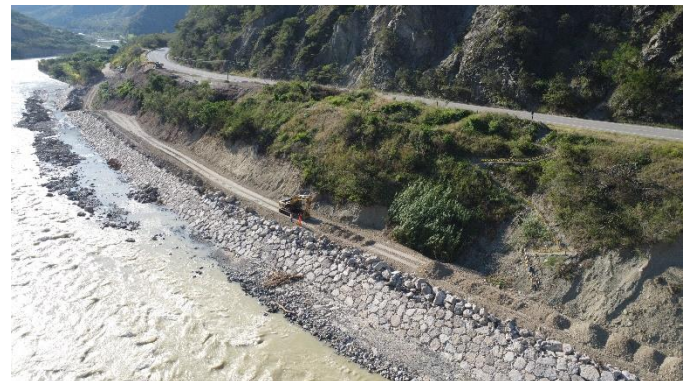
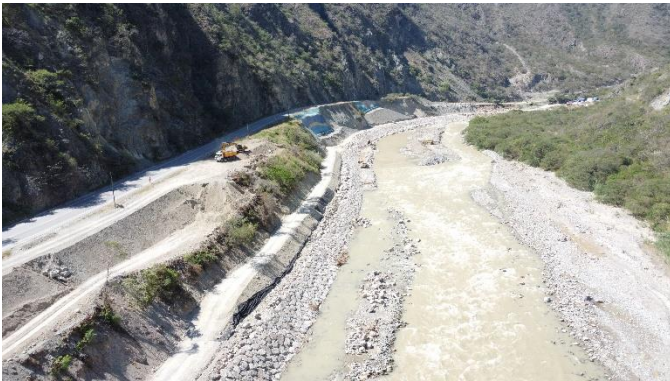
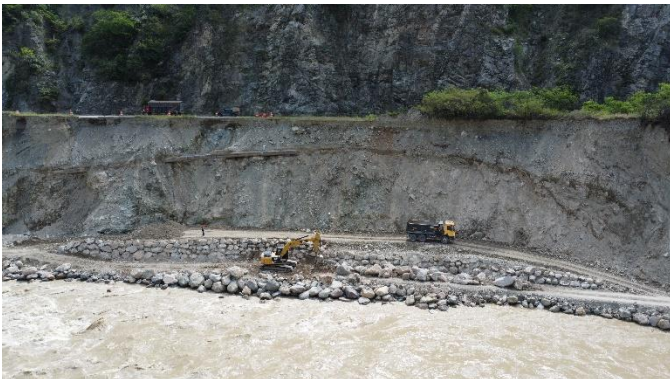
FIGURE 20: CONSTRUCTIVE PROCEDURE OF REAR FILL OF RIPRAP.

This work consists of the placement in strata, conformation and compaction of suitable materials coming from the same excavation, and cut material on the Right of Way or from the Quarries. The material for the formation of fills came from the cut material on the right of way and quarry material. The compaction depended on the area where it was carried out, special care was taken so that the instability of the slopes does not compromise the personnel and equipment that carry out the work. The equipment for spreading, accommodation, and compaction of the fill was an excavator, motor grader, tractor, and smooth vibratory roller. The placement of the fill was carried out using horizontal layers of no more than 0.40 m thick. The level of the crown of the rockfill, that is, the upper 0.40 m of the fill, was compacted in two layers.

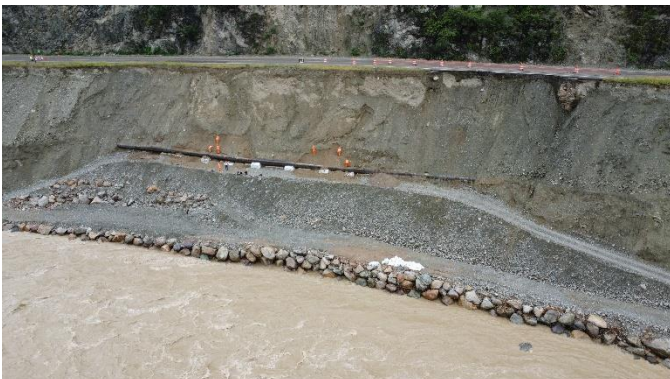
FIGURE 23: FILTER LAYER PLACEMENT CONSTRUCTIVE PROCEDURE.

This work consisted in the construction of the filter layer behind the riprap and with the dimensions indicated in the project plans or indicated by the Supervisor.

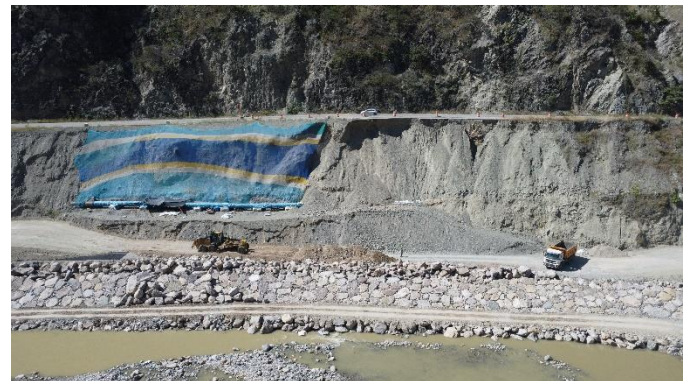
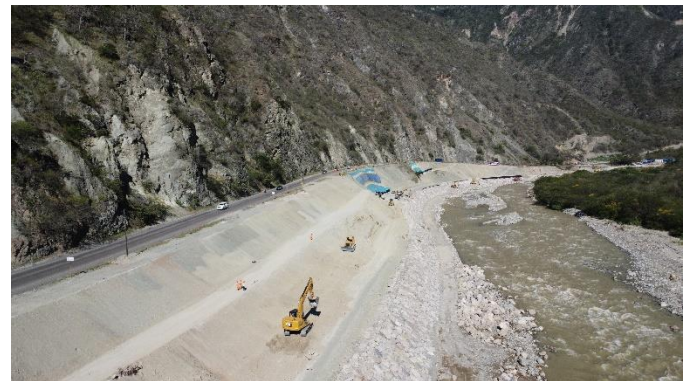
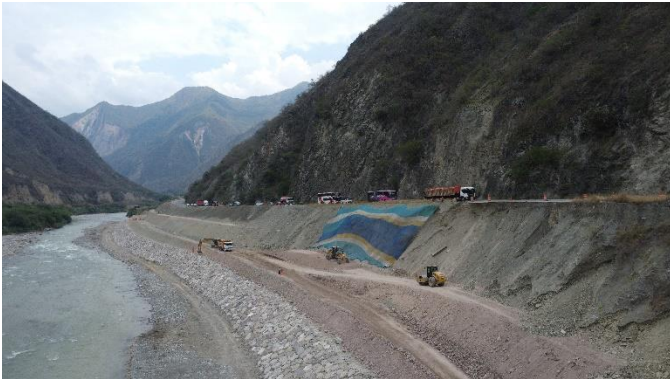
FIGURE 24: CONSTRUCTION PROCEDURE FOR TERRACE FILING.

This work consisted of the placement in strata, conformation and compaction of suitable materials from the same excavation from cuts of the material on the Right of Way or from Quarries 1 and 4. The material for the conformation of fills came from the material of cut on the right of way. The compaction was carried out in the entire area, as long as the instability of the slopes did not compromise the personnel and equipment that carried out the work. The equipment for the spreading, accommodation, and compaction of the fill was an excavator, motor grader, and vibratory smooth roller tractor. The placement of the fill was carried out using horizontal layers of no more than 0.40 m thick. The level of the crown of the rockfill, that is, the upper 0.40 m of the fill, was compacted in two layers.

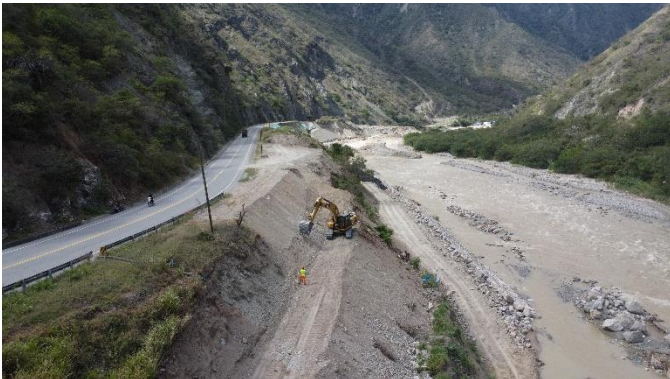
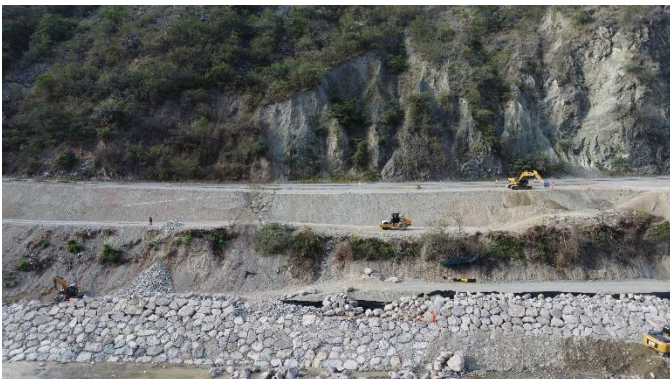
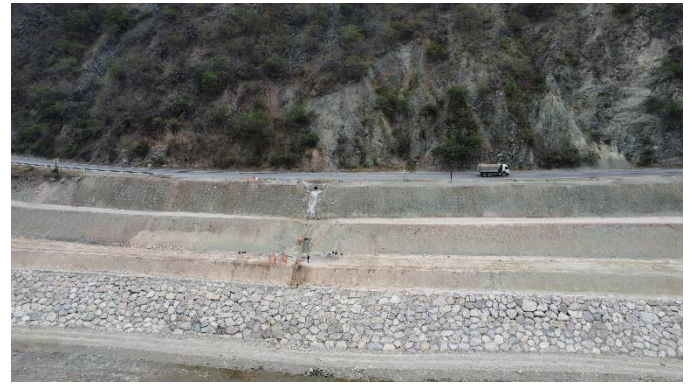
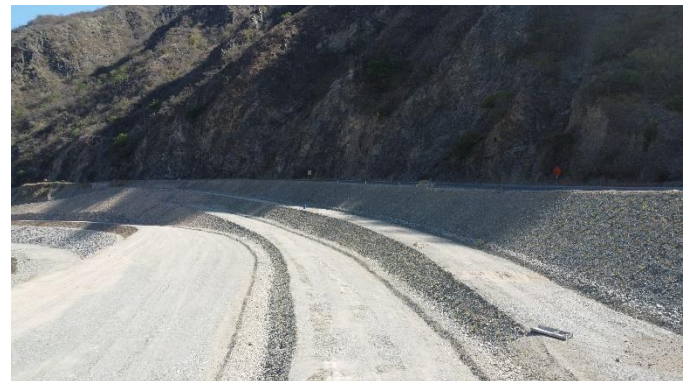
FIGURE 27: CONSTRUCTIVE PROCEDURE OF CUTE FOR TERRACE.

This work consisted of the set of activities of excavating, removing, loading, the materials coming from the cuts required for the leveling, indicated in the plans and cross sections of the project. Materials from excavation were used to improve accesses, fill for riprap, and fill for the terrace

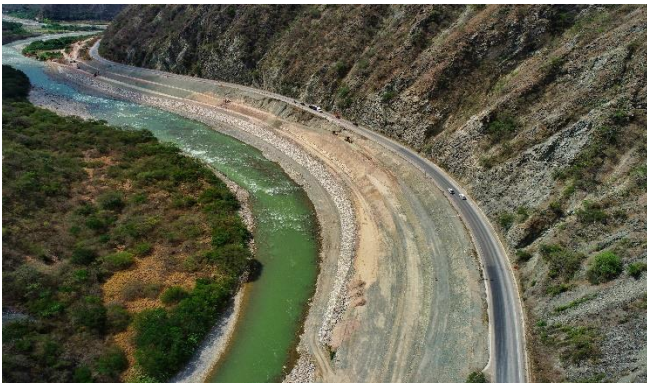
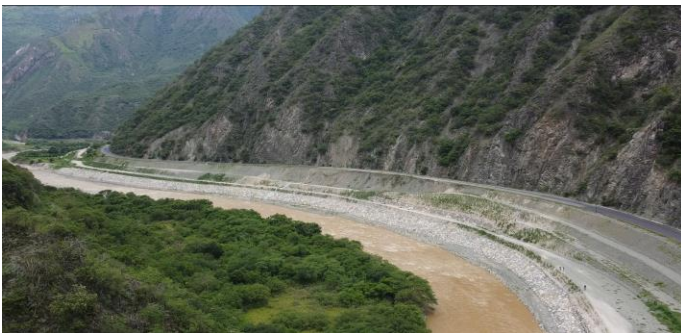
FIGURE 31: CULMINATE RIPRAP.

Another great challenge was the large amount of rock needed and the few quarries close to the area. The construction of the river defense fulfilled the purpose of recovering the Right of Way at Km 563.2 ONP.
