PREDICTIVE MANAGEMENT IN PIPELINE-TO-LANDSLIDE INTERACTION – A CASE STUDY

Carlos Motta¹, Jaime Aristizabal¹

¹CENIT Transporte y Logística de Hidrocarburos
Bogotá D.C., Colombia

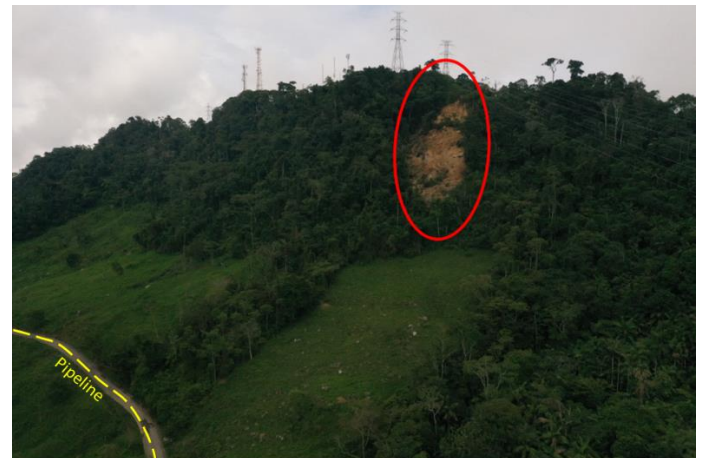
In October 2022, through RoW Patrol the rock fall from a scarp, and their accumulation at the toe of the slope were identified, 200 m upslope from RoW, on a Colluvium deposit (see **Figure 5** and **Figure 6**).

FIGURE 5. OCT. 2022. ROCK FALL LOCATED UPSLOPE OF THE ROW.

Because of this condition, a monitoring plan was established to visit it at last two times per month. In November 2022, one month later, a toe bulge was identified (see **Figure 7**), and during the following two (2) weeks, the instability process evolution was denoted by the following aspects:

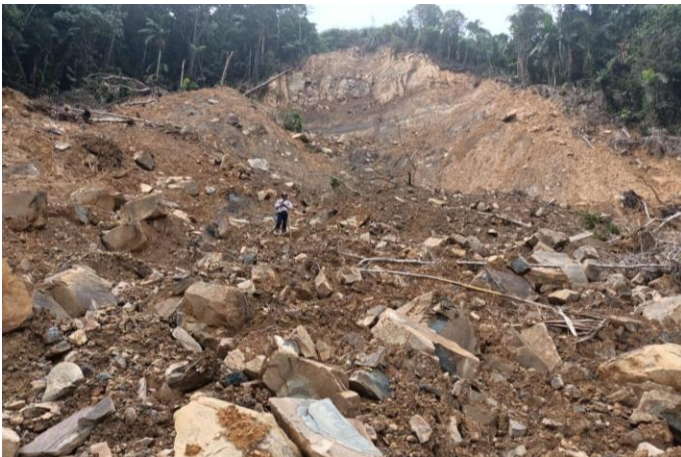
FIGURE 6. ROCK FALL AT THE TOE OF MAIN SCARP.

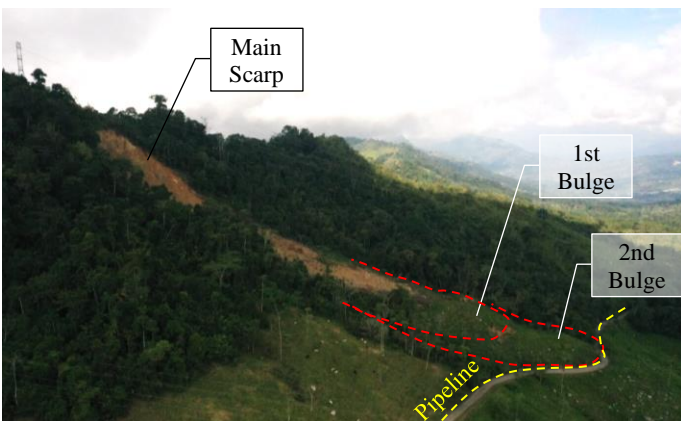
- A second toe bulge located downslope from the previous one (see **Figure 7**).
- Rise of the road's drainage ditch due to lateral load (see **Figure 8**).

FIGURE 7. DEC. 2022. TOE BULGES IDENTIFIED

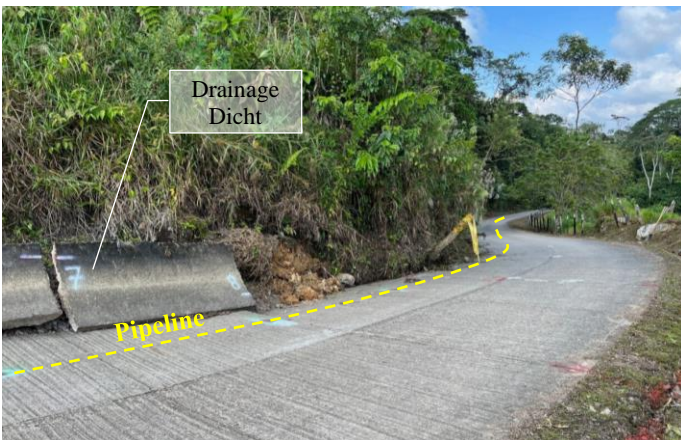
FIGURE 8. RISE OF THE ROAD'S DRAINAGE.

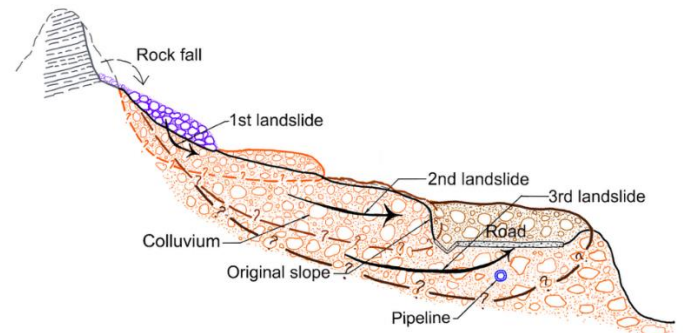
Given the characteristics observed in the landslide evolution, and by its activity (SGC, 2017), a successive landslide was identified such as the one illustrated in **Figure 9**. This condition represents an imminent interaction between landslide and pipeline, considering the shallow depth at which the pipeline was located (of about 2 m) compared with failure surface inferred.

FIGURE 9. ILLUSTRATIVE DIAGRAM OF THE SUCCESSIVE LANDSLIDE IDENTIFIED.

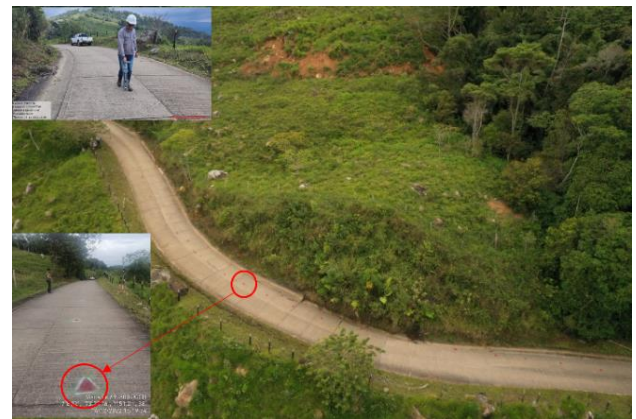
FIGURE 10. SURFACE DETECTION AND MARKING OF PIPELINE ALIGNMENT.

In addition to the first monitoring plan implemented, the pipeline was detected and its location was marked on the concrete pavement slabs (see **Figure 10**), as well as specific points of interest, to identify progress in the interaction between the landslide and RoW (i.e. monitoring of the opening in concrete pavement slabs joints – see **Figure 11**).

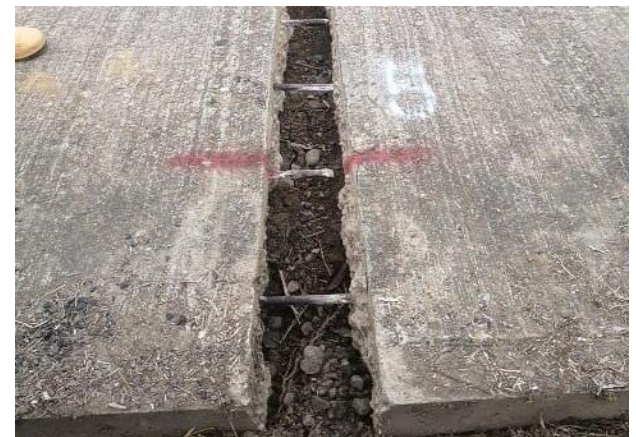
FIGURE 11. MONITORING OF THE OPENING IN CONCRETE PAVEMENT SLABS JOINTS.

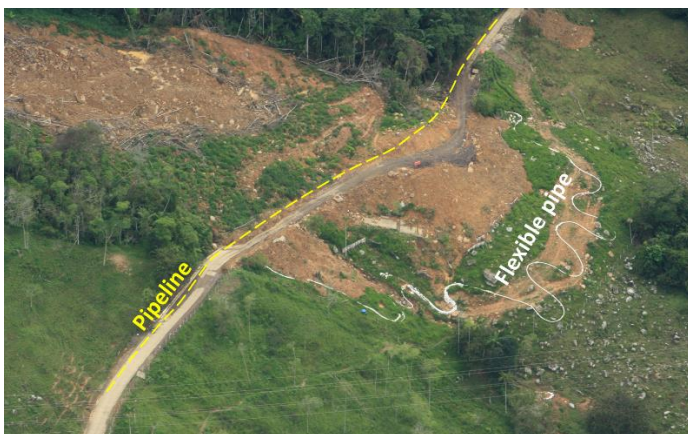
FIGURE 13. BYPASS IN FLEXIBLE PIPE (6").

In an expert judge workshop, it was established that the most appropriate temporary solution for the conditions of the site was the construction of a bypass in flexible pipe.

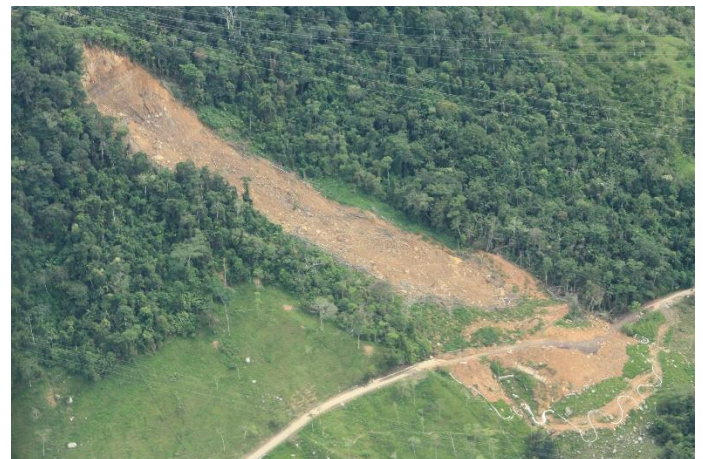
Due to activity of the landslide and its evolution, in addition to third party activities to recover the road's transit (see **Figure 14**), what were considered in the temporary solution decision-making process, it has been necessary to relocate the flexible pipe four times without impacts for integrity of the system.

FIGURE 14. JUN 2023. TEMPORARY SOLUTION OVERVIEW.
