### DECISION-MAKING AND MITIGATION ACTIONS, INCLUDING DEADMAN ANCHORS AND FLEXIBLE PIPES FOR PIPELINE ADJACENT TO ROAD INFRASTRUCTURE - A CASE STUDY

#### ABSTRACT

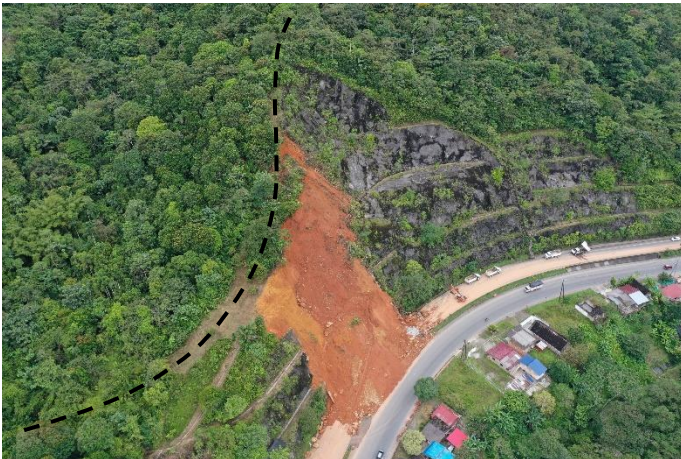
Regarding this case study, in September 2022 there was a landslide on the cutting slope of road that destabilized pipeline right of way. Because of high slope and geological-geotechnical conditions there was retrogression of the movement scarp until leaving exposed and hanging approximately 80 meters from the pipeline. The landslide is estimated to have a width and a length of about 80 meters, and in its displacement disrupted road traffic from and to main foreign trade port of Colombia. Figure 1 shows an overview of the event in September 2022 and in a dashed black line, the approximate alignment of the pipeline is observed.

FIGURE 1. LANDSLIDE OVERVIEW – SEP 2022

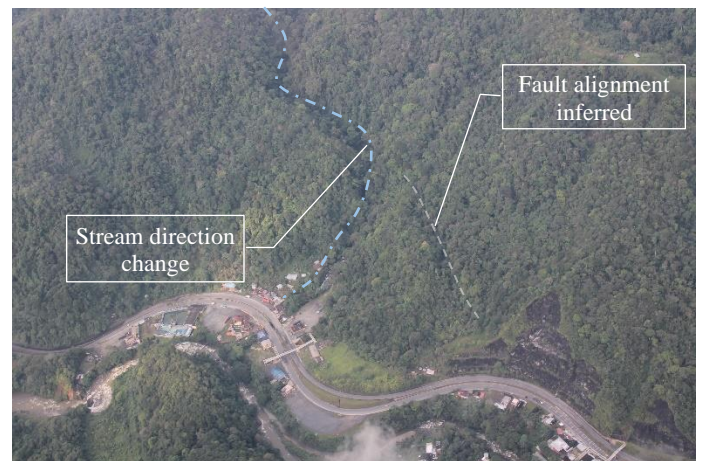
The course of the stratification of the fold and cleavage axes is normally parallel to the direction of the range, although individual blocks bounded by faults may be parallel or subparallel to the limiting faults. It can be thought that local variations are mainly due to the presence of intrusions or the rotation of differential horizontal movements along limiting faults, and it is possible to observe in direction changes of streams and in geomorphological features as shown in Figure 3.

FIGURE 3. INFERRED FAULT ALIGNMENT – MARCH 2018

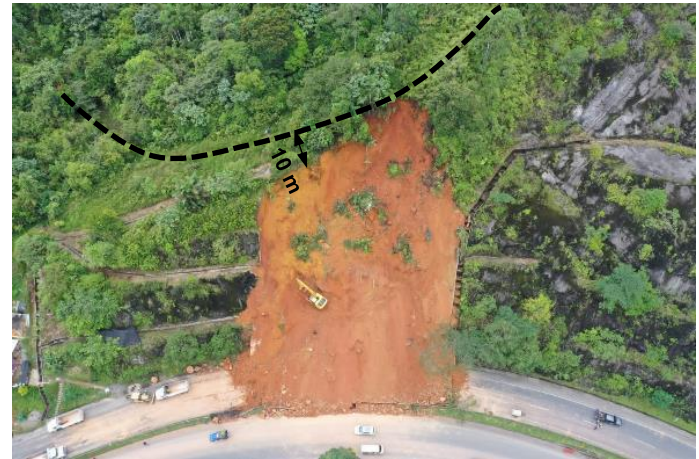
Once CENIT identified in September an instability process through its inspection plan, it began the verification of the condition that included pipeline location, as well as a drone inspection, initially identifying a scarp retrogression between 10 and 15 meters (Figure 5), that is, 10 meters away from the pipeline. This landslide reactivation includes the failure of anchored system (including lagging wall with reinforced shotcrete) built by road operator.

FIGURE 5. LANDSLIDE SCARP RETROGRESSION – SEP 2022

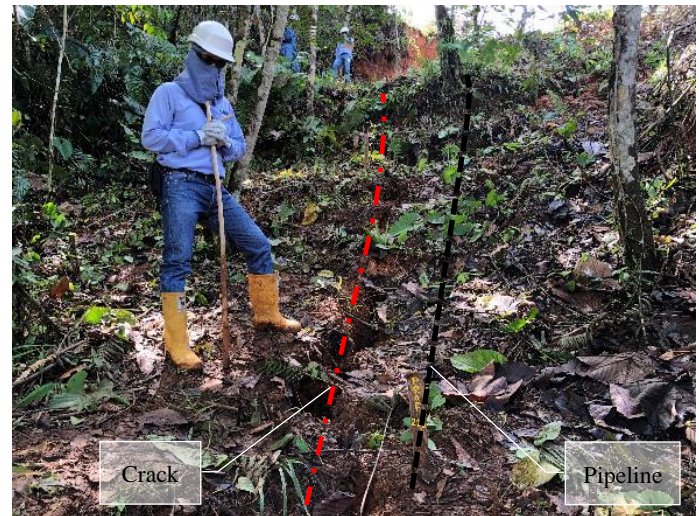
Between the end of September and October beginning, the crown of the landslide, begins to present cracks that represented advances in the retrogression of the landslide (Figure 6) of about 4 m each time, due to inherited discontinuities, as was possible to identified. Because pipeline was underground in the crown, the interaction with the instability process was causing lateral loads on the pipeline.

FIGURE 6. CRACKS IDENTIFICATION IN THE LANDSLIDE CROWN

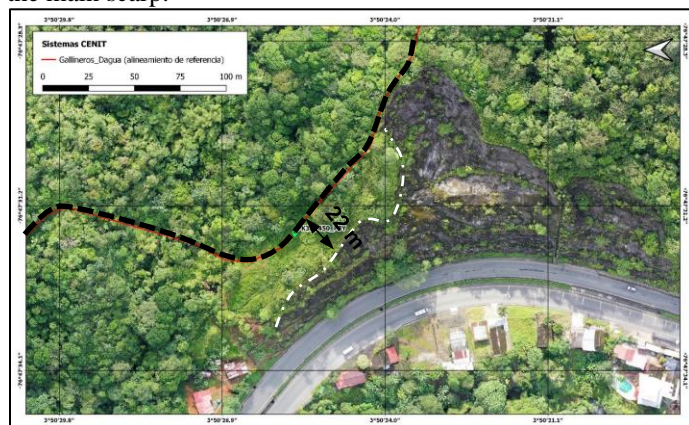
When road expansion activities were carried out, more than 10 years ago, the road operator stabilized its cutting slopes through anchored system. This stabilization was necessary, due to a landslide that occurred when executing the slope cuts, and after completion, the main scarp was 22 m from the alignment of the pipeline, as shown in Figure 4.

FIGURE 4. LANDSLIDE AND PIPELINE ALIGNMENT OVERVIEW – AUGUST 2019

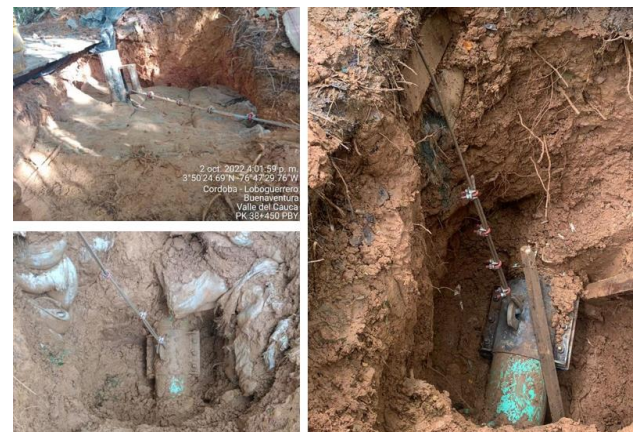
FIGURE 7. ATTACHMENT SYSTEM

In this same period, CENIT in a Reactive Management Approach, began the construction of an attachment system to provide support to the pipe, composed by Deadman anchors, guy line and clamps which were tied to the pipeline as shown in Figure 7, as a preventive action in case of a new retrogression of the main scarp.

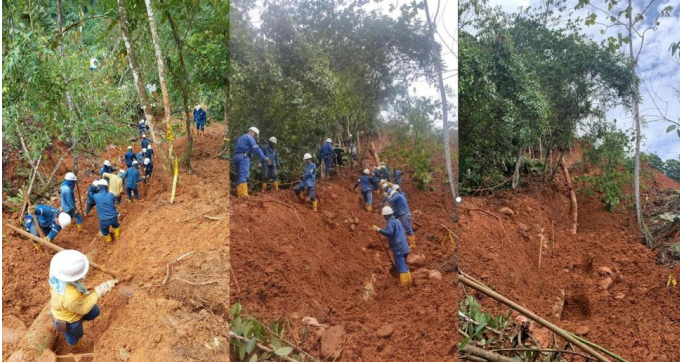
**FIGURE 8. MANUAL EXCAVATION TO STRESSES RELIEF**

CENIT begins pipeline stresses release where the cracks had been identified. These had to be executed manually, for the reasons stated above (Figure 8).

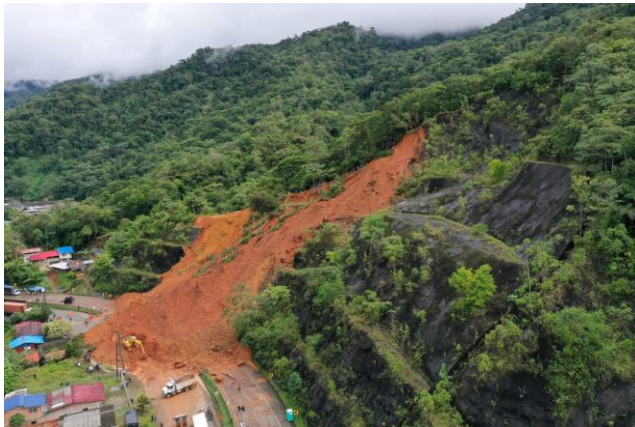
At the next day landslide crown collapses exposing the pipeline, and the attachment system built begin to work structurally. Thanks to pipeline stress release activities from the previous day and to the attachment system arranged, and despite the collapse of landslide crown, pipeline integrity of the pipeline. This collapse also generated the total closure of road (Figure 9).

**FIGURE 9. LANDSLIDE OVERVIEW AFTER CROWN COLLAPSE**

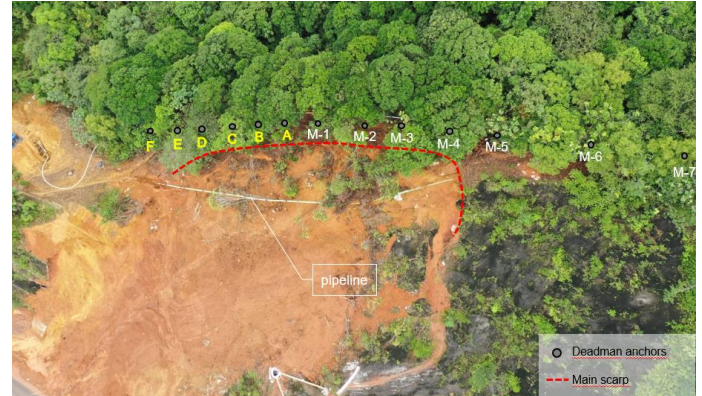
In the following days, as landslide evolved, left a pipeline section of about 80 meters long exposed and hanging at the main scarp, and a complete attachment system (composed by seven deadman anchors were built in addition to six installed as a preventive measure during the event of more than 10 years ago), was operational. On average deadman anchors were installed four meters from the main scarp, at the opposite end of the narrow ridge that was constituted (see Figure 10, Figure 11, and Figure 12).

**FIGURE 10. LOCATION AND DISTRIBUTION OF DEADMAN ANCHORS**

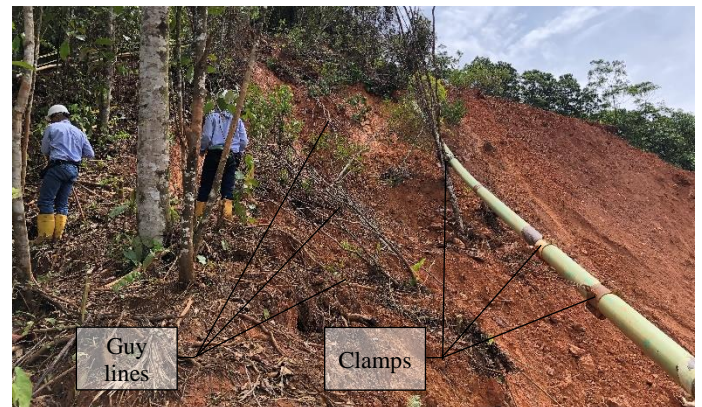
**FIGURE 11. PIPELINE AND ATTACHMENT SYSTEM VIEWED FROM MAIN SCARP**

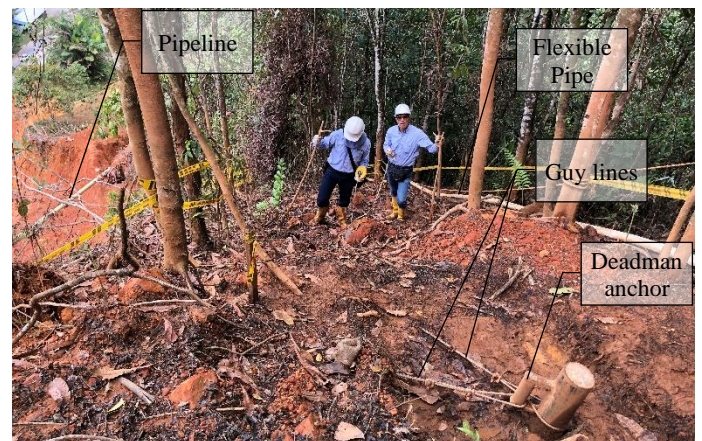
**FIGURE 12. NARROW RIDGE OVERVIEW NEAR TO MAIN SCARP**

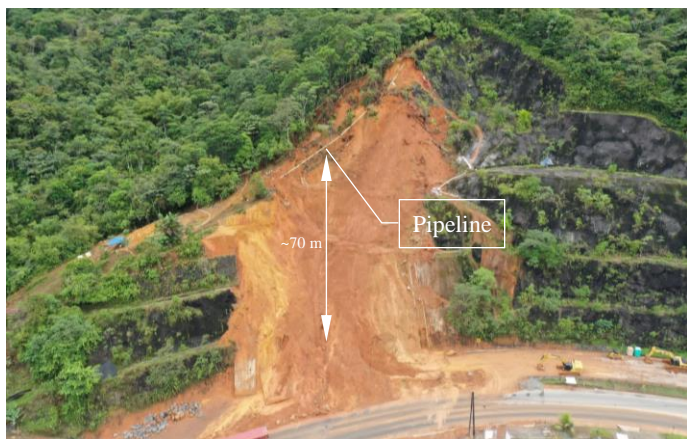
**FIGURE 13. PIPELINE CONDITION AFTER LANDSLIDE RETROGRESSION**

decided to prolong decision to halt pipeline operation, and with the aim of reactivating it and guaranteeing supply of fuels for the west of the country, was advance in an alternative plan, which consisted of installation of a section of flexible pipe above ground of approximately 400 meters in length, parallel and attached to the same deadman anchors.

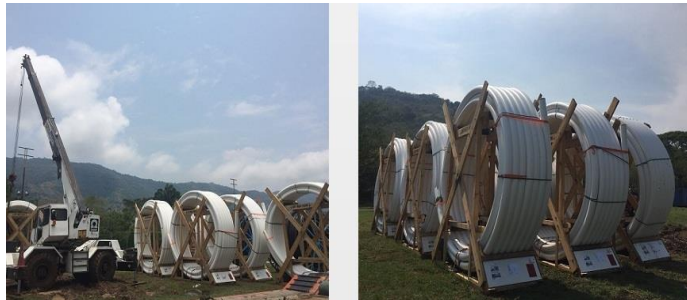
**FIGURE 14. FLEXIBLE PIPE SPOOLS**

A flexible pipe is a non-metallic pipe qualified for use in water, gas, and oil at high pressures, elaborated and certified under the API RP 15S standards. It is based on non-ferrous materials, so it does not corrode. Special anti-UV white that externally coats the pipe protects it from sunlight, so, it allows above ground or buried disposition. Flexible pipe is transported by means of spools (see Figure 14). Figure 15 shown a temporary solution overview and Figure 16 and Figure 17, shown flexible pipe installed and operative.

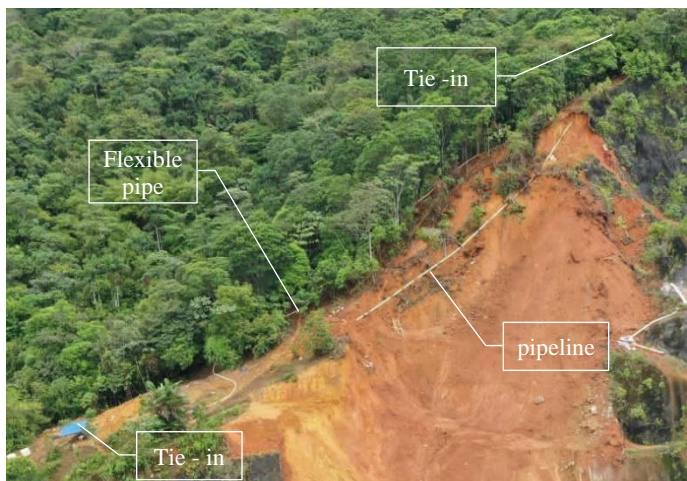
**FIGURE 15. TEMPORARY SOLUTION OVERVIEW**

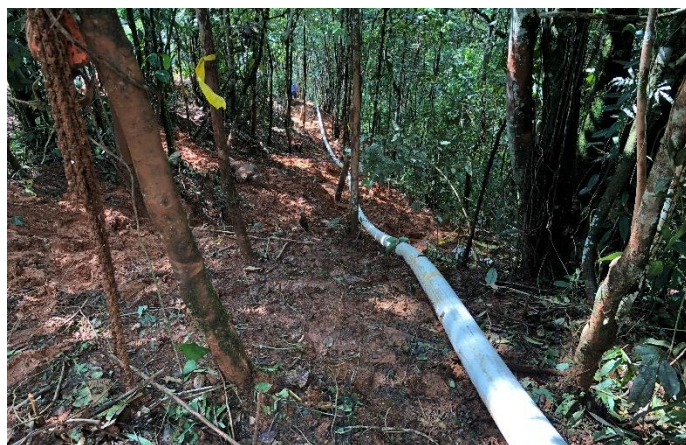
**FIGURE 16. FLEXIBLE PIPE HALFWAY UP THE SLOPE**

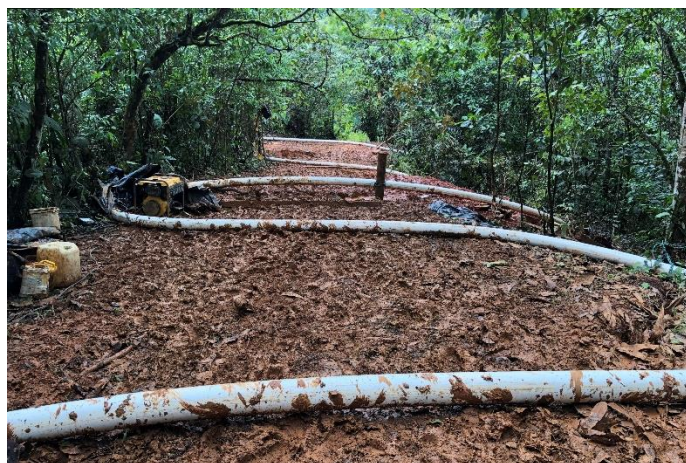
**FIGURE 17. FLEXIBLE PIPE ON NARROW RIDGE**
