## AN INTEGRATED DECISION-MAKING PROCESS IN EMERGENCY CONDITIONS DUE TO GEOHAZARDS – A STUDY CASE

Carlos Pedraza<sup>1</sup>, Jaime Aristizábal<sup>2</sup>, Carlos Motta<sup>2</sup>

<sup>2</sup> CENIT, Transporte y Logística de Hidrocarburos  
Bogotá D.C., Colombia

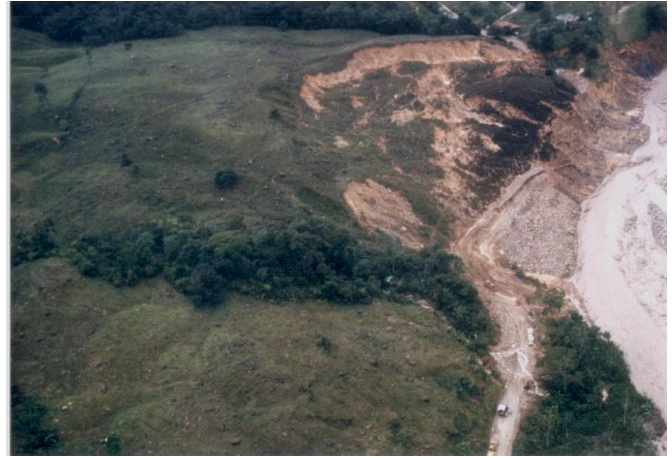
80's processes were associated with wandering channel of stream that attacked the toe of colluvial deposit where both, pipeline and “La Soberania” road, are located. For this reason, after loss of containment on September 14, 1986, it was decided to make a variant, which began before site of the event, passed “La China” stream and advanced along the left bank in a flat area, until crossing “El Caraño” stream and joining with the initial alignment. On April 25, 1993, there was a high-speed landslide that overloaded alluvial deposit generating a lateral fault of this, causing the pipe to be uncovered and displaced laterally with total rupture.

**FIGURE 2:** LANDSLIDE OF 1984, NOTE HOW THE STREAM UNDERMINED COLLUVIUM'S TOE (Photography by José Vicente Amórtegui IGL).

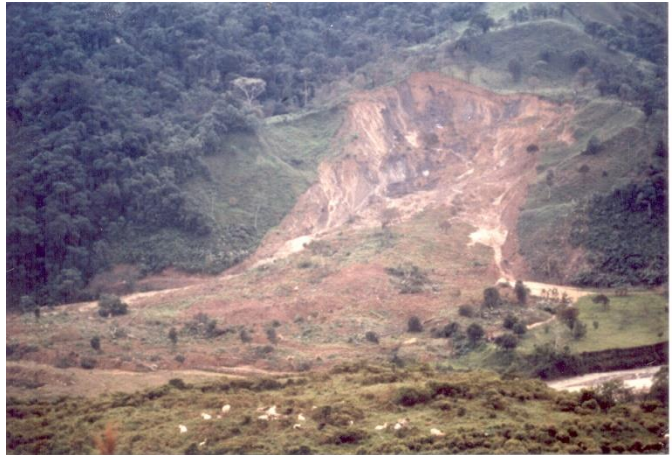
**FIGURA 3:** LANDSLIDE OF 1993, NOTE HOW MATERIAL FLOWED OVER ALLUVIAL DEPOSIT CAUSING PIPELINE TO COME ABOVE GROUND DUE TO LATERAL DISPLACEMENT (Photography by José Vicente Amórtegui IGL).

Faced with this loss of containment, ECOPETROL decided to resume the initial route by building a large rockfill to protect the left bank of “La China” stream, accompanied by horizontal drains, French drains, metal piles, ditches for water management and terraced the front area of slipped area. Initially pipeline was left above-ground parallel to road but was later buried leaving a section inside a chamber formed by steel sheet to isolate pipeline from unstable ground.

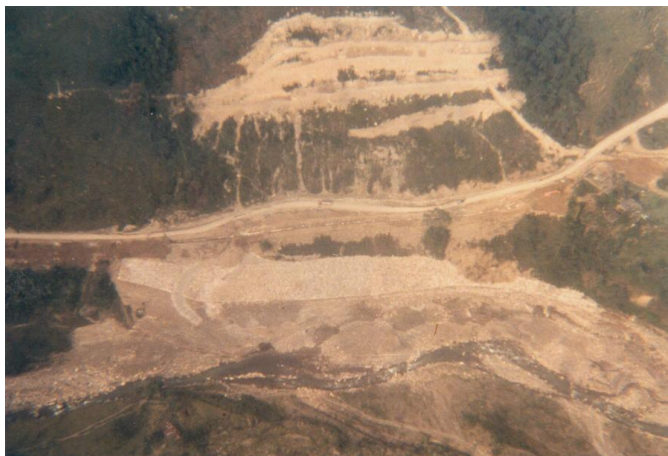
**FIGURA 4:** STABILIZATION WORKS CARRIED OUT BETWEEN 1994 AND 1997 TO PLACE PIPELINE IN INITIAL ROW (Photography by José Vicente Amórtegui IGL).

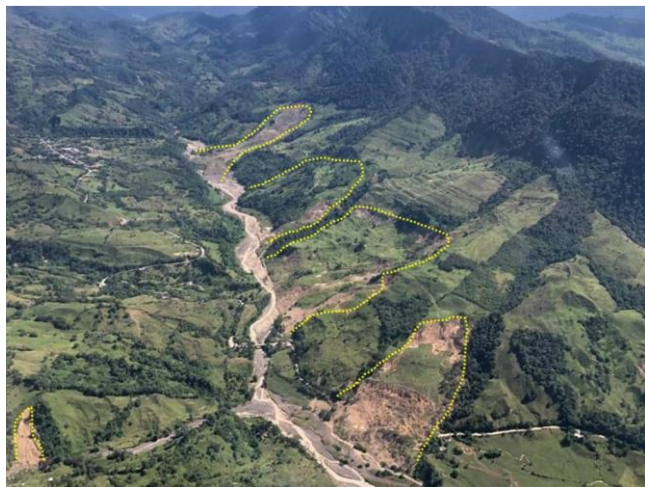
2023, at 11 am and ended on August 3 at 1 am, for a total rainfall of 314 mm (Figure 7) with hourly intensities that reached 34 mm. The event affected several villages in the Sarare area, impacting several towers of the 230-kW power line of the Toledo – Samoré – Banadía systems, the La Soberanía road at least in 8 points with total or partial closure and the Gibraltar – Bucaramanga gas pipeline affected in about 4 km. Additionally, there were dams and later avalanches in the La China and El Caraño streams (Figure 8).

**FIGURE 8: LANDSLIDE PROCESSES LOCATED IN LA CHINA BASIN.**

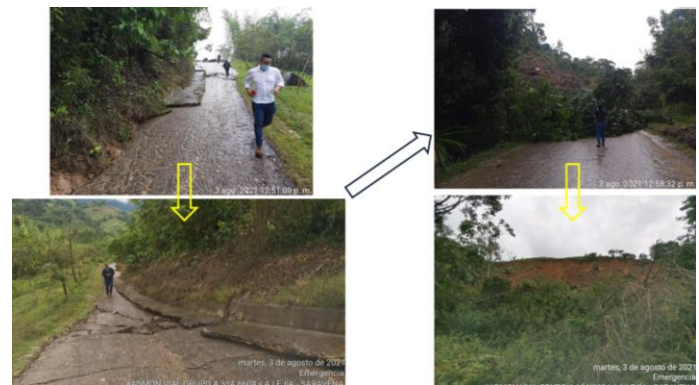
Before the day of landslide a precipitation warning (thanks to applied meteorological monitoring predictive schemes – IPG2019-5343 [3], IPG2021-65003 [4] and IPG2023-0045 [5]) had been generated that specified the need to advance ROW patrol; as a result of that patrol it is identified, in the early hours of the morning, that in the zone there is a retrogression of the main scarp of the 1986 event. Towards noon began a flow of land on the left flank that closes “La Soberanía” road, and this advance lasted about an hour until completely closing the road, (Figure 9). Figure 10 shows the appearance of the hillside according to the photo, taken with a drone from CENIT’s Geohazards Management Strategy, on August 3 at 4 pm. It is

possible to see the earth flow completely covering “La Soberanía” road and how ROW was not yet affected by the process. Also, in the upper part a main scarp was observed with a height that by that time already exceeded 10 m; this scarp followed alignment of a slope change that did not slide located on the right side.

**FIGURE 9: LANDSLIDE SEQUENCE THAT COVERS “LA SOBERANÍA” ROAD (Photographs by road Operator).**

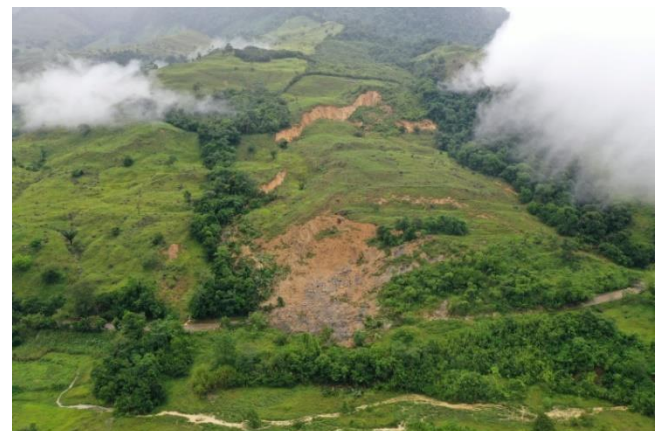
According to data collected towards early hours of the night, general fault was presented, impacting ROW, which generated the loss of containment. Landslide mass has a width of 250 m, an approximate length of 500 m, main scarp reaches 45 m so the volume exceeds 3 million cubic meters, according to the classification of Fell (1994) [6] is considered as very large.

**FIGURE 10: HILLSIDE CONDITION ON AFTERNOON OF AUGUST 03, 2021.**

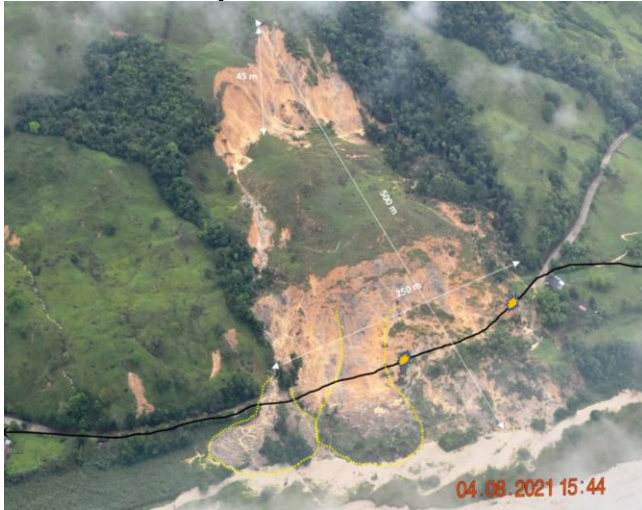
Based on drone orthophotos monitoring, a multitemporal analysis of images was carried out to determine the probability of having a retrogressive or successive process as well as displacement vectors of the slipped mass. From this, it was determined that middle and upper parts of the landslide largely retain their shape, despite the displacements evidenced of about 45 m (Figure 11). From this displacement, and time it took to

reach it was calculated that landslide speed exceeded 4 m per hour, so it is considered “fast” according to the classification of Cruden and Varnes (1996) [7]. With these speed characteristics and magnitude, it is defined that process has a very high destructive power where escape is possible for people, but structures were destroyed.

**FIGURE 11:** LANDSLIDE OVERVIEW ON THE AFTERNOON OF AUGUST 04, 2021, (Photography by Lázaro Castillo).

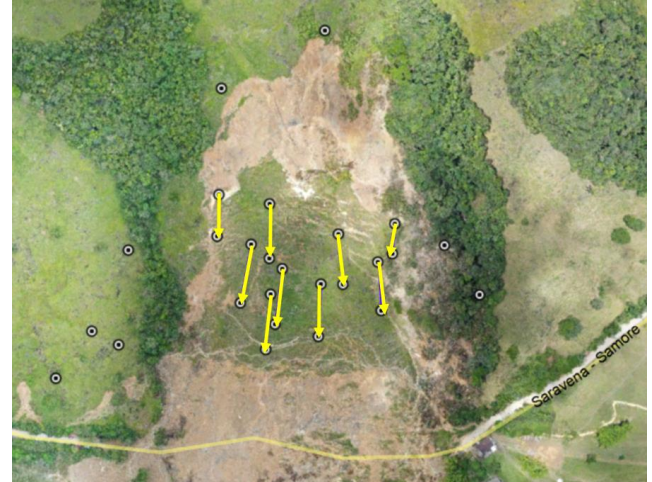
**FIGURE 12:** LANDSLIDE DISPLACEMENT VECTORS OBTAINED FROM MULTITEMPORAL ANALYSIS OF ORTHOPHOTOS TAKEN WITH DRONE.

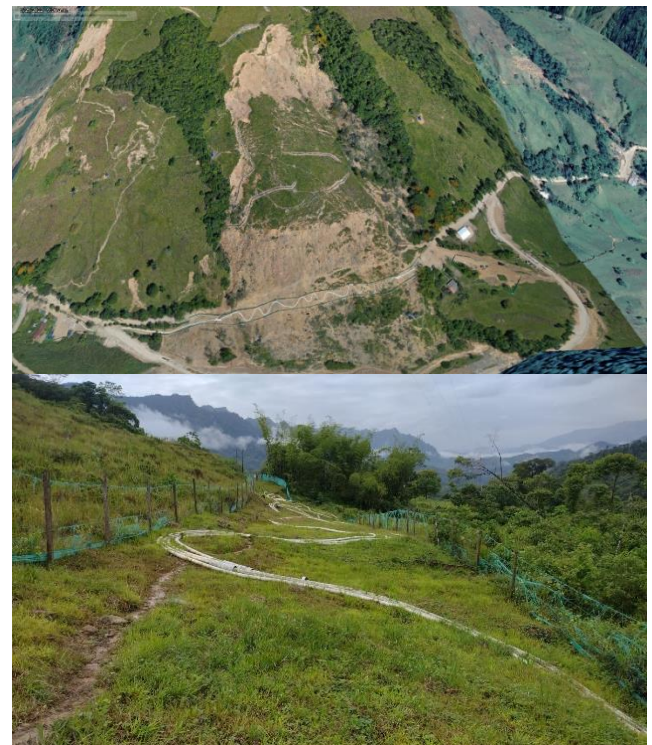
**FIGURE 13:** FLEXIBLE PIPE FINAL DISPOSITION.

Given the impossibility of building a variant that would avoid landslide due to environmental and social restrictions, precarious stability conditions of the slope located on the right flank and consistency of material slid on ROW, it was necessary to implement a system of flexible pipes, located on the ROW, that would allow to comply with the minimum operating flow of the system. Once the hydraulic analysis was carried out by the CENIT team, it was determined that four flexible pipes of six inches connected to two multiple ones were required working at a pressure of the order of 750 psi. Additionally due to maintenance needs required in this sector, it was necessary to

install a trap to capture stopper backs that are used in repairs arising from actions of illegal third parties. As one of the risks that existed was that the process of instability was reactivated or new material slipped from the upper slope, it was decided to install flexible pipe giving it a sinusoidal shape so that it could move up to 50 m before entering tension, in this way it was possible to rearrange flexible pipes in case of movements in the ground and the risk of breakage was reduced. in the face of a new process of instability (Figure 13).
