IPG2025-007

IMPACT OF ROCKFALL ON HYDROCARBON TRANSPORTATION PIPELINES

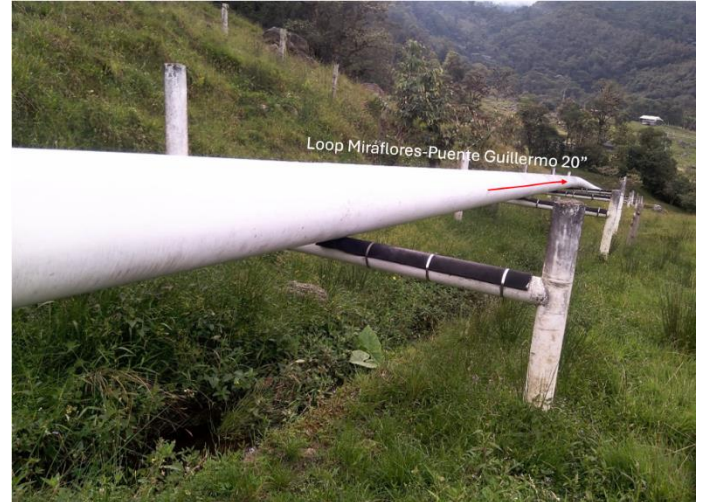
FIGURE 1: Location of the 20" loop on H-frames

As part of the integrity management strategy of Transportadora de Gas Internacional TGI S.A. ESP, aerial, ground, and geotechnical monitoring inspections are conducted on its gas pipelines. The case study focuses on the Cusiana–El Porvenir–La Belleza gas pipeline, specifically the Miraflores–Sutamarchán segment, located in the municipality of Miraflores, Boyacá, Colombia. In this segment, TGI operates two 20-inch diameter pipelines: the Miraflores–Sutamarchán trunk line and the Miraflores–Puente Guillermo. Geologically, the area is located on the Une Formation (Kiu), composed of fine to coarse-grained quartz sandstones with thin interbedded black shales. Locally, the gas pipeline lies on Quaternary colluvial deposits dissected by parallel drainage channels, with extremely slow movement rates as recorded by geotechnical monitoring. The trunk pipeline is buried at a depth of 2.1 meters, while the 20" loop pipeline is supported on H-frames to reduce vulnerability to soil creep from the colluvial deposit (see FIGURE 1).

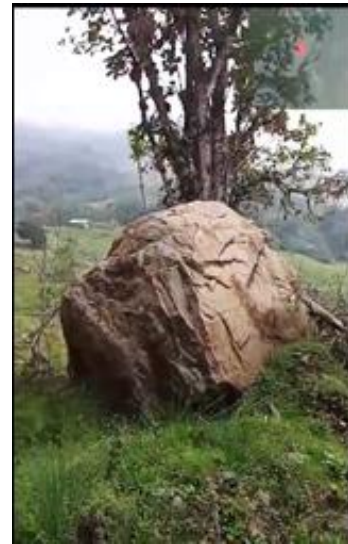
FIGURE 2: Rock block approximately 2 meters high supported by the trunk of a tree

FIGURE 3: A-A terrain profile, showing the distance relationship between the rock block and the pipeline

In February 2025, right-of-way patrol and geotechnical monitoring technicians identified a sandstone block approximately 2 meters in diameter located on the hillside adjacent to the pipeline, next to a tree situated 45 meters from the loop. The tree trunk was bearing the block's weight (see FIGURE 2 y 3).

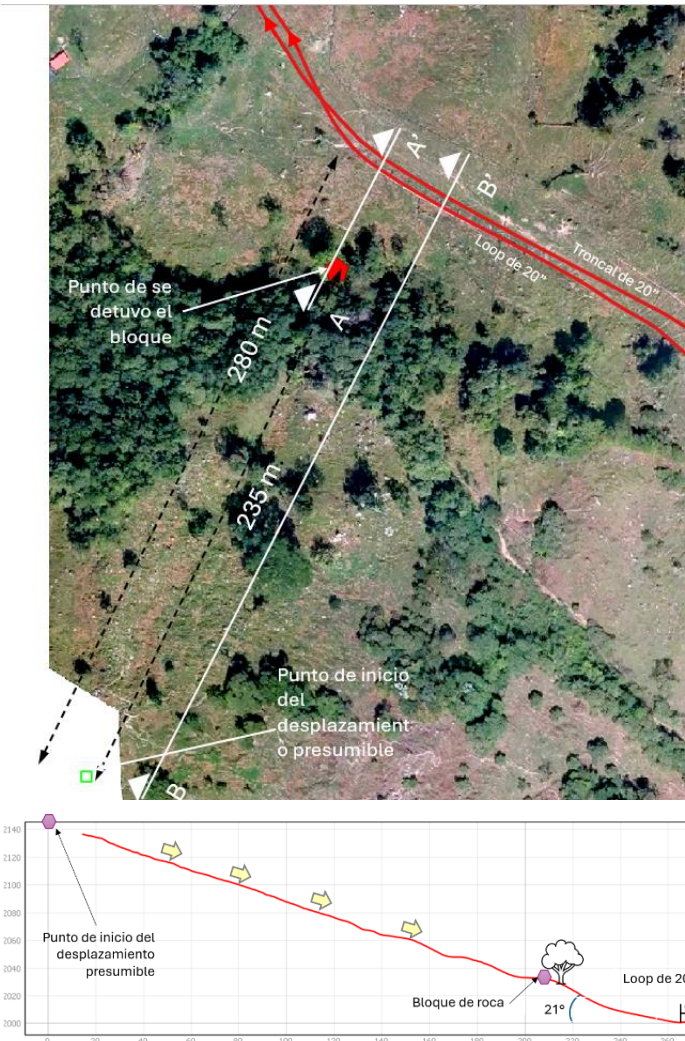
FIGURE 5: Plan view showing the location of the block. Bottom – Profile B-B’ of the block’s trajectory.

Using the digital elevation model (DEM) obtained from LiDAR (Light Detection and Ranging) topography, the terrain profile, path, and slope of the hillside along which the block descended were defined, up to the point where it was stopped by the tree. The trajectory was directed toward the aerial 20” loop pipeline. Ver FIGURE 5 Plan and Profile.

Table 1 presents the results for calculating the kinetic energy of the rock block. A 2-meter side sandstone block falling along a 21° slope over a 280-meter length would develop a kinetic energy of 1377 kJ.

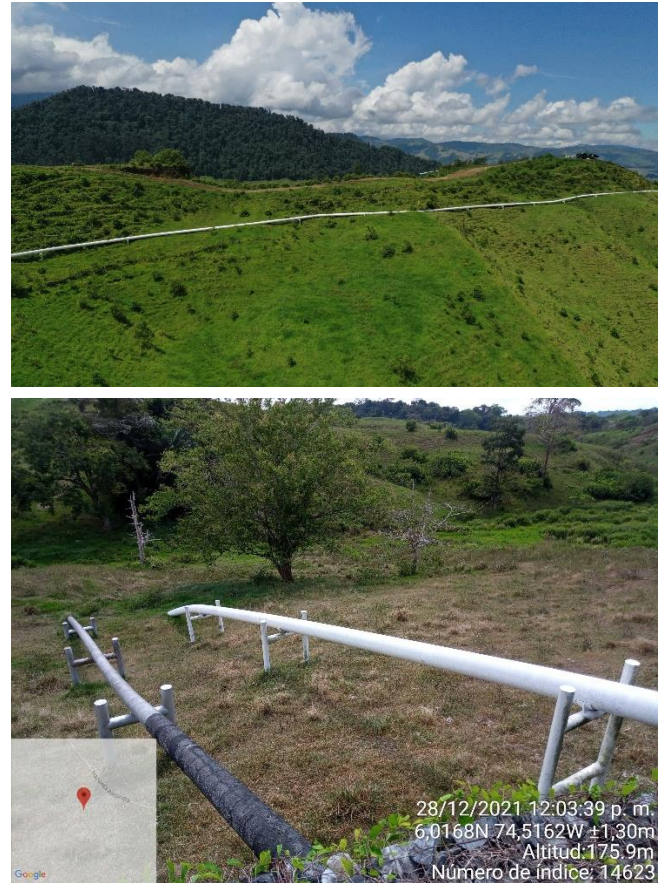
FIGURE 7: Top – Surface-level segment excluded from the analysis due to its location at the top of a slope composed of volcanic deposits, near the ridge, where the possibility of rockfall impact is null and there are no adjacent slopes contributing rocky material. Bottom – Surface-level segment excluded from the analysis for the same reason: located at the upper part of a slope with volcanic deposits, near the ridge, with no potential for rockfall impact or contributing rock sources from adjacent slopes.

Among the surface-level segments, some are located at the upper parts of slopes, broad ridges, or flat areas where rockfall is not possible. FIGURE 7 illustrates examples of segments excluded from the analysis due to their location in areas with no adjacent contributing slopes.

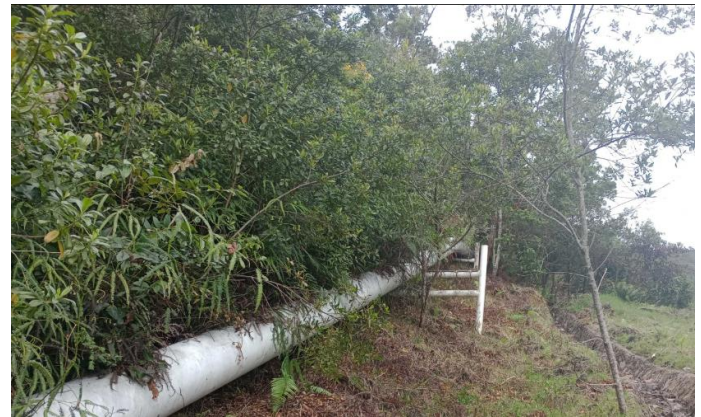
FIGURE 9: PK96+263 of the 20" Loop in the Miraflores – Puente Guillermo section, showing a 280 m slope on the left side with a 21° gradient and dense vegetation cover, where block displacement is not possible.

At this stage, a more detailed review can be made of the surface roughness or characteristics of the vegetation cover and terrain surface. This allows for the exclusion of segments with dense or semi-dense forest or shrub cover, as shown in FIGURE 9. Under this condition, 1 segment was excluded, leaving 8 potentially susceptible segments.

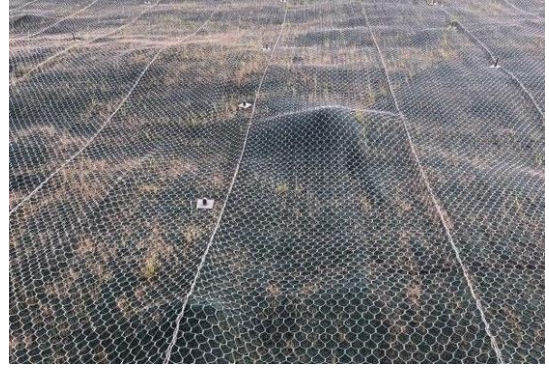
FIGURE 12: Example of a rock mass stabilized with mesh and bolts/anchors

These systems use high-strength meshes with varying aperture sizes, making them adaptable to different block diameters. The meshes can be anchored directly to the slope or rock mass using bolts and anchors, as shown in FIGURE 12.

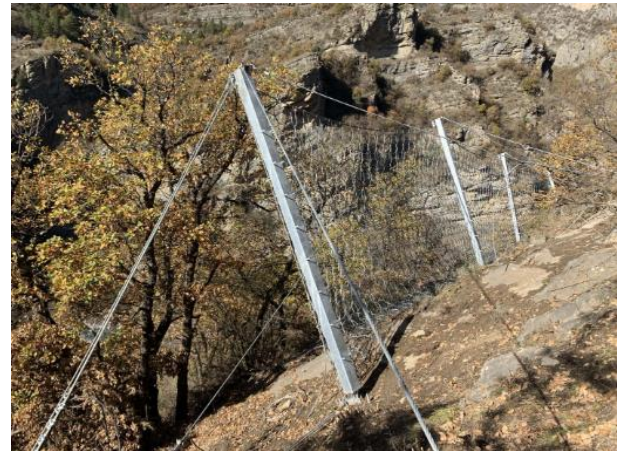
FIGURE 13: Example view of a dynamic retention barrier

They can also be installed as freestanding retention barriers (see FIGURE 13), similar to metallic crib-type structures, where steel posts or tubes are driven into the ground and the high-strength mesh is mounted onto them. These barriers can withstand impact energies of up to 9000 kJ.
