PRIORITIZATION CRITERIA FOR DEBRIS FLOW ENGINEERING WORKS TO PROTECT PIPELINES IN THE BRAZILIAN SERRA DO MAR REGION, SÃO PAULO

¹Petrobras Transporte S.A – Transpetro, Rio de Janeiro, RJ, Brazil

6TH INTERNATIONAL PIPELINE GEOTECHNICAL CONFERENCE IPG 2023

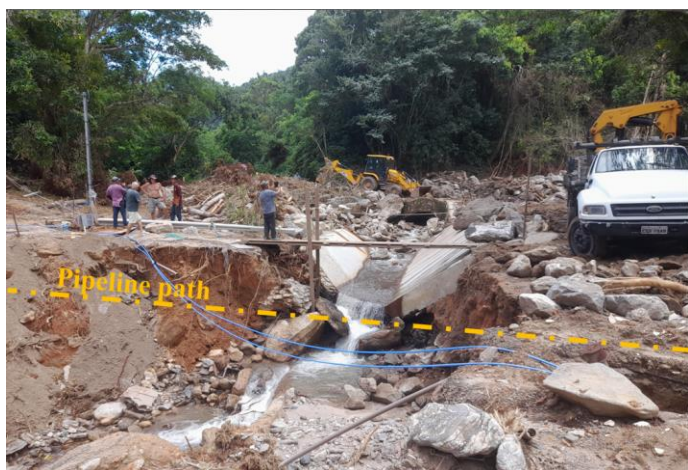
Figure 1 – Debris flow occurred due to the rainfall event of February 2023 in OSBAT, km 11+050, and the channel built an year earlier that protected it.

During the field investigations a debris flow was found where the pipeline crosses a river, on the km 11+050 of the ROW. On that place, an engineering work completed in May 2022 avoided a drastic pipeline failure that would have been if it were not for preventive studies performed years ago with the goal of pinpointing places where debris flow was critical to the pipeline.

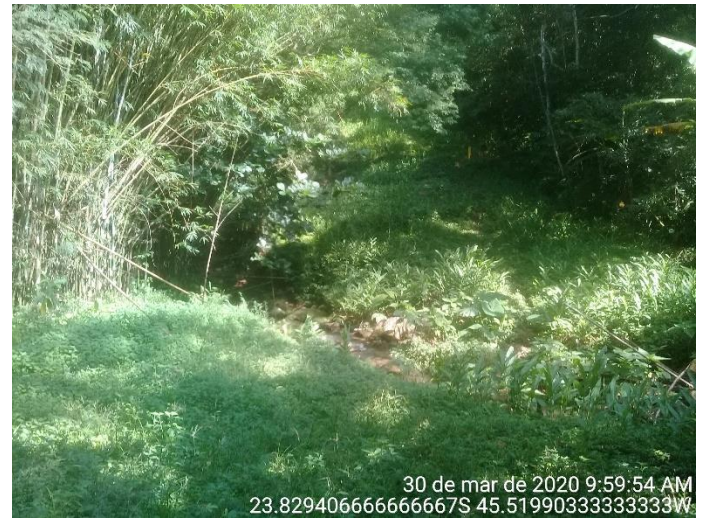
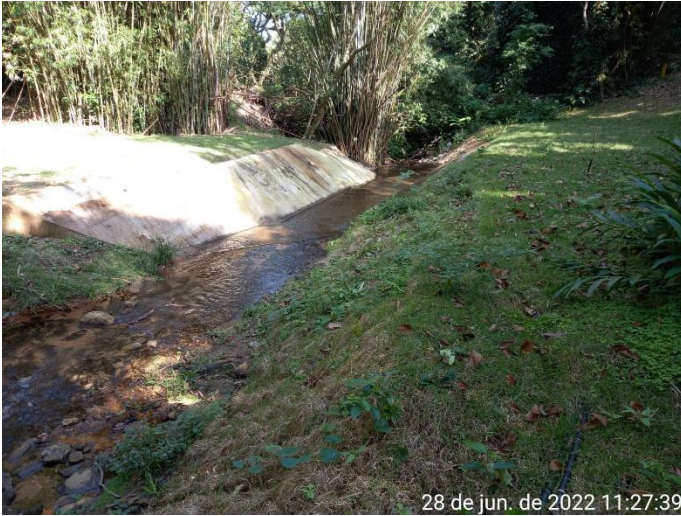
Figure 4 – Hydraulic Catchment 6 (OSBAT km 10+600). (a) river path before the channel construction; (b) river path after the channel construction.

The works started on December/2021, and they finished by March/2022. Figure 4 and Figure 5 show the rivers path before and after the channel construction. Figure 6 and Figure 7 show some details of the channel projects, such as the 3D modelling and profile.

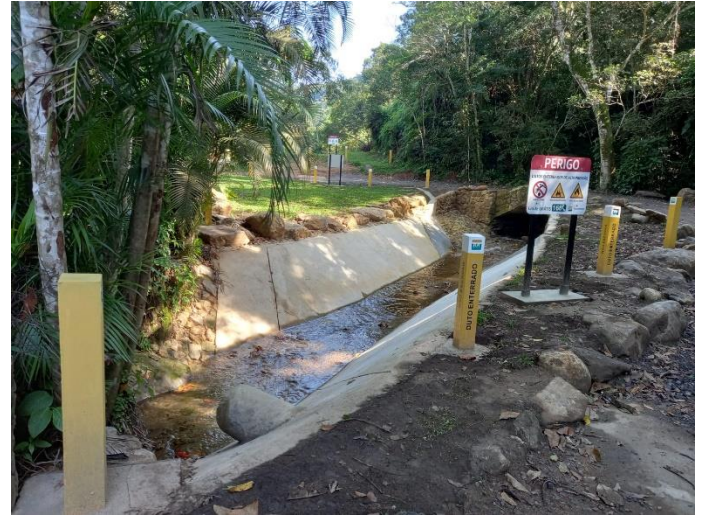
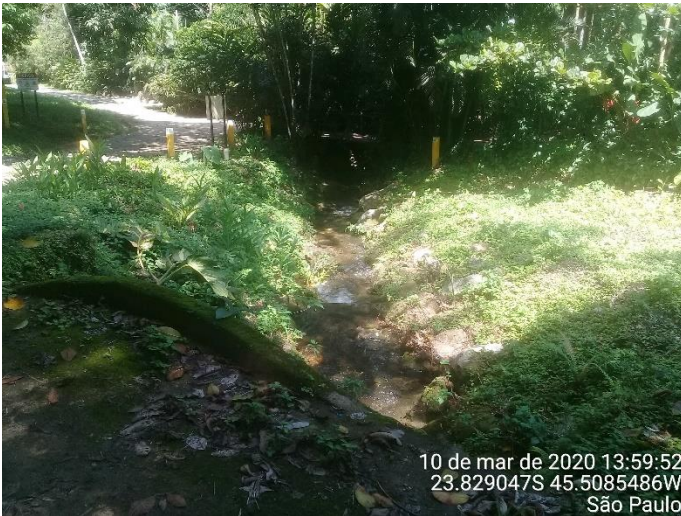
Figure 5– Hydraulic Catchment 7 (OSBAT km 12+100). (a) river path before the channel construction; (b) river path after the channel construction

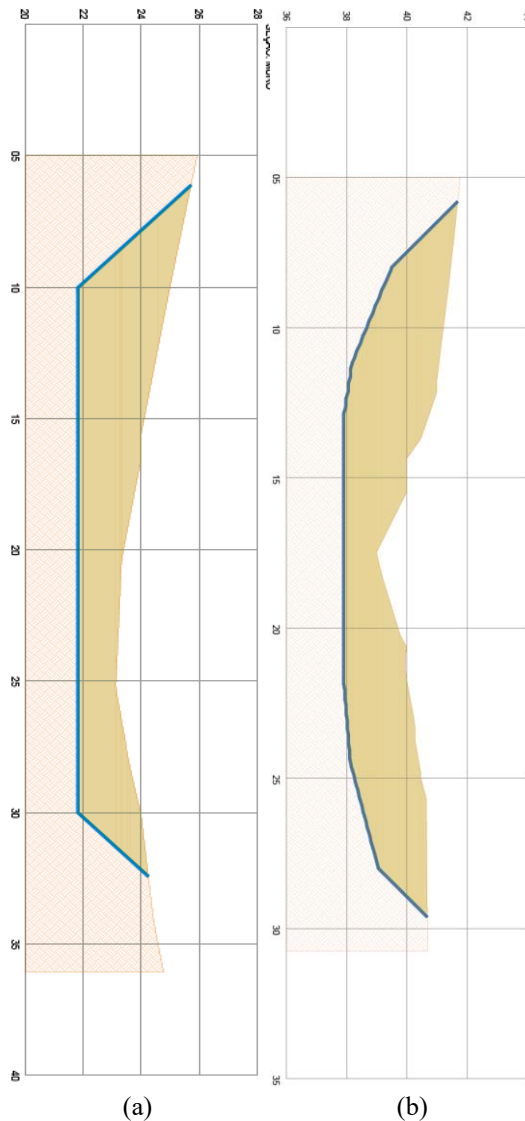
The excavation profile that resulted from the numerical studies for catchments 6 and 7 are in shown in Figure 9.

Figure 9 – Excavation profiles for catchments 6 (a) and 7 (b).

The project took into consideration the excavation profile predicted in the RAMMS numerical modeling for the protection of the pipeline. This was done while considering the peak discharge for a 60-minute rain intensity with a return period (TR) of 100 years. Under these conditions, the estimated flow velocity was 5 meters per second. The reaction forces take into account the confinement/passive effort of the protection channel within the limits of the pipeline's right-of-way on both sides of the channel.

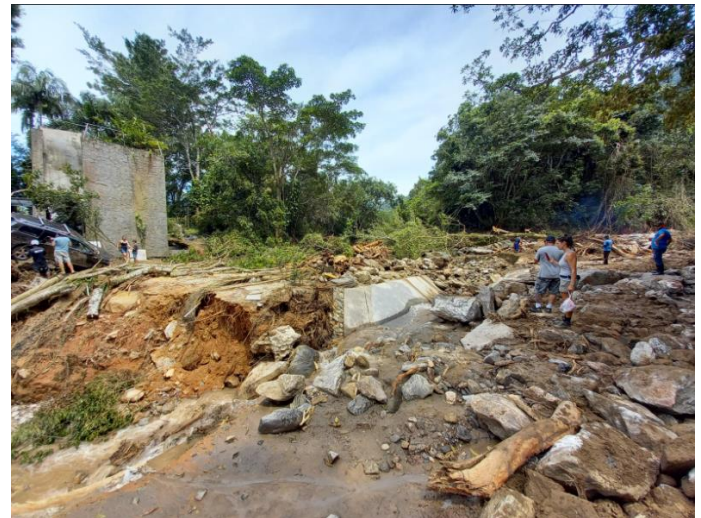
Figure 10 – picture of the concrete channel of hydraulic catchment 8 after the debris flow event of February 2023.

In February 2023, the region encountered the most extensive rainfall event ever recorded in Brazil, with rainfall reaching 684 mm within 11 hours. A total of 52 geotechnical events, ranging from low to high risk for the pipelines, were detected. One of these events consisted of a debris flow that impacted the catchment 8, causing wreckage along the river path and to the surrounding community. A 24" oil pipeline buried with 1,5 m depth passes under the mentioned river. The debris flow excavated around 2 m of the river's bottom after the channel, which shows that the channel had significant influence over the erosion profile along the river's path, since the erosion did not change the river's bottom immediately before the channel along the river's path. The concrete channel guaranteed the protection of the pipeline, avoiding a clear failure, as can be seen in Figure 10. Catchment was not affected by any debris flow.

Although the pipeline ROW was indeed affected by the debris flow, the pipeline remained intact, showing that the completion of the channel was crucial to the integrity of the pipeline. The outcome of the debris flow showed that the prioritization process was successful in defining areas that needed immediate mitigation.
