6ª CONFERENCIA INTERNACIONAL GEOTECNIA DE DUCTOS

IPG2023-0039

ADVANCES IN GEOTECHNICAL MONITORING OF GAS PIPELINES: APPLICATION OF UAV FOR EFFICIENT AND SAFE MANAGEMENT

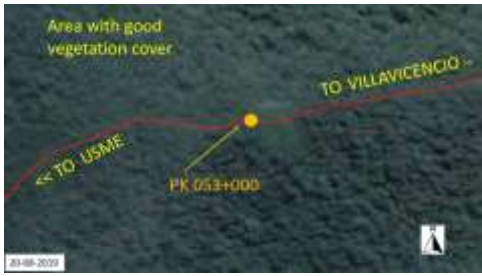
Date	Image
20-08-2019

Table 5.1 Background of Site 4 - Apiay - Usme Mainline

Based on the conducted tracking (see **Table 5.1**), vegetation loss is identified on the left side of the pipeline at a distance of 44 meters in September 2020. By January 2022, an advancement in the flow is observed, with the flow being 18 meters away from the pipeline and covering an area of 2400 m². Additionally, another area with vegetation loss on the right side is observed at a distance of 34 meters.

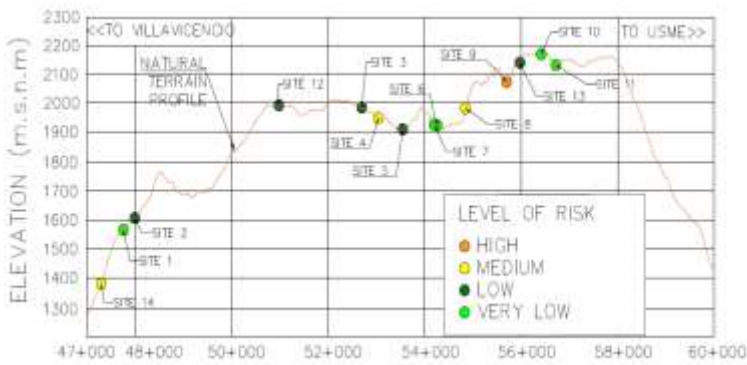
Figure 6.1 depicts the longitudinal profile of the pipeline between station PK47+000 and PK60+000, with the locations of the sites of interest.

Figure 6.1 Longitudinal profile of the pipeline between station PK47+000 and PK60+000. (Scale 1V:5H)

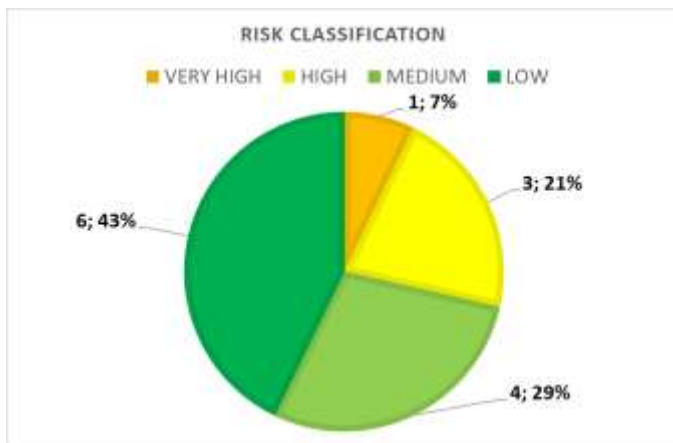
Figure 7.1 Results of Risk Classification

Table 7.4 presents the resulting weights from applying the parameters outlined in the matrix for the geotechnical risk assessment due to flows in areas with high slopes and dense vegetation. Additionally, in Table 7.5, the filled out "RAM" matrix is presented, taking into account the results obtained for each evaluated point. In Figure 7.1, a graphical representation of the number of findings by obtained risk level is shown.
