IPG 2025-#00--

## "GEOTECHNICAL PROTECTIONS IN RIVER CROSSING, PK 20,500 PUESTO HERNÁNDEZ - LUJÁN DE CUYO - ARGENTINA OIL PIPELINE"

Leandro Ivorra<sup>1-2</sup>

1 Operational Inspection Analyst – Geotechnical Engineer – YPF SA, La Plata, Argentina.

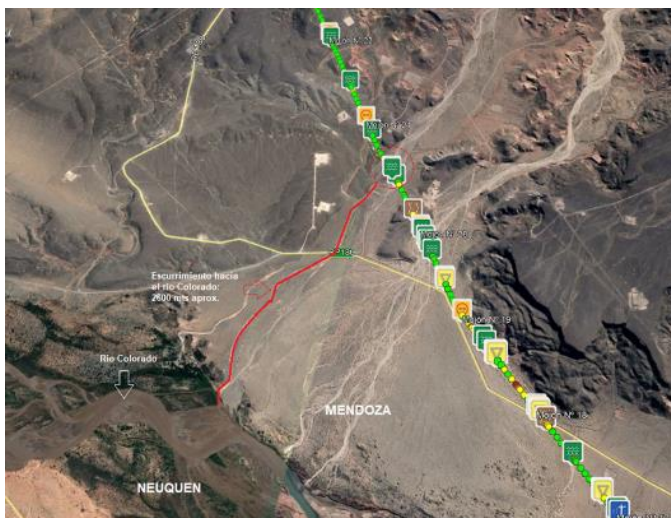
A risk analysis was carried out that showed the criticality of the pipeline. Within this analysis, design data, hydrological and tectonic hazards, among others, were included, and the possible environmental damage was also considered, since the pipeline is located approximately 2600 meters along the Colorado River.

**FIGURE 12** – Location of the pipeline in relation to the Colorado River – Source: Google Earth

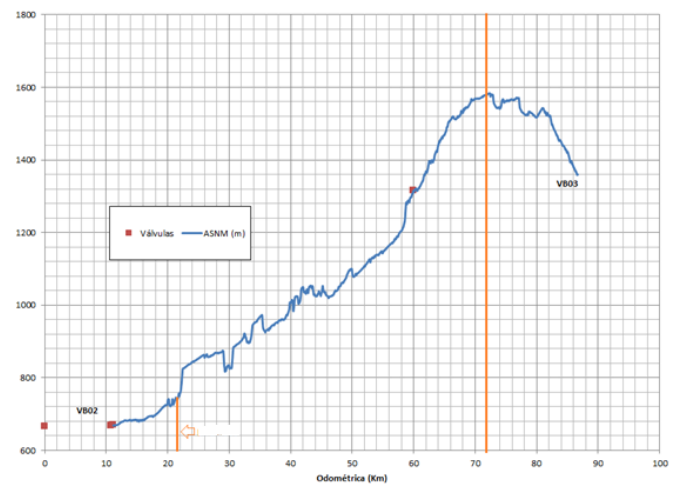
The nearest block valves are VB 2 pk 12 (9.1 km away) and VB 3 pk 88 (approx. 67 km away).

**FIGURE 13** – Altimetry between VB – Source: Authr of the paper.

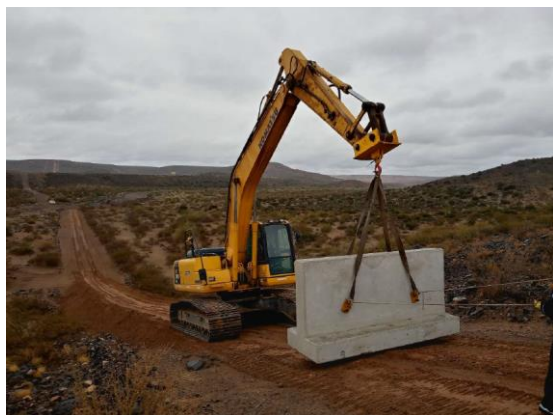
**FIGURE 19** – Equipment moving a sleeper –  
Source: Author of the paper

The transfer of these elements was not a minor issue, not only because of the remoteness, but also because of the topography to access the work.

The slope of a hill had to be changed by providing material so that trucks and other equipment could get around it and reach the foot of the work with the concrete blocks and the equipment itself.

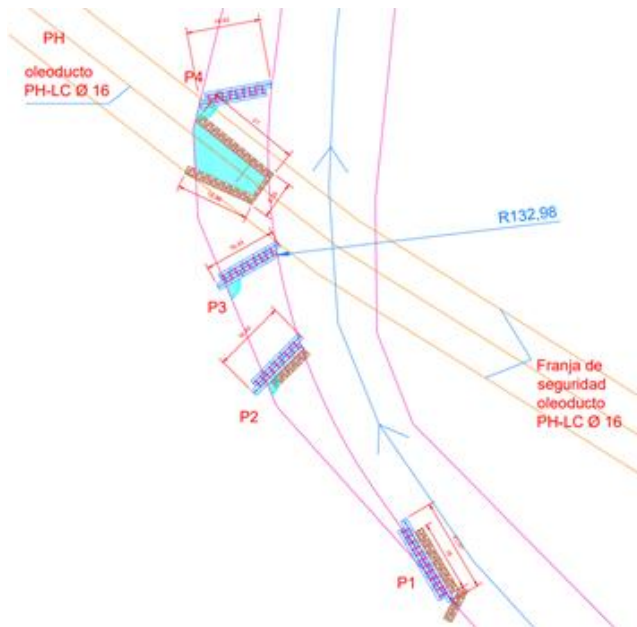
**FIGURE 23** – General Implementation of Protections -  
Source: Author of the paper

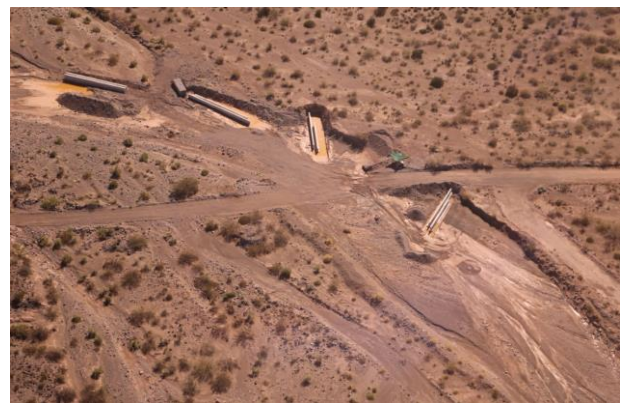
**FIGURE 25** – Aerial view of the construction site - Source:  
Aerial patrol

The P2, P3 and P4 protections must have an inclination towards the centre of the channel so that their elevation reaches one metre above the level of the slab of the riverbed.

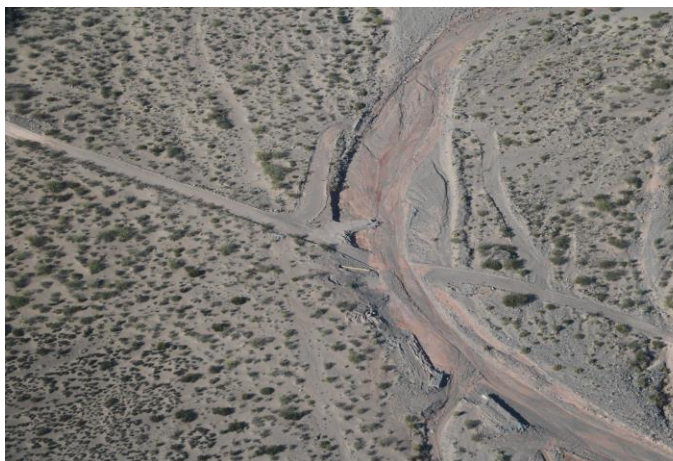
**FIGURE 31** – Aerial view of completed work 2 - Source: Aereal patrol

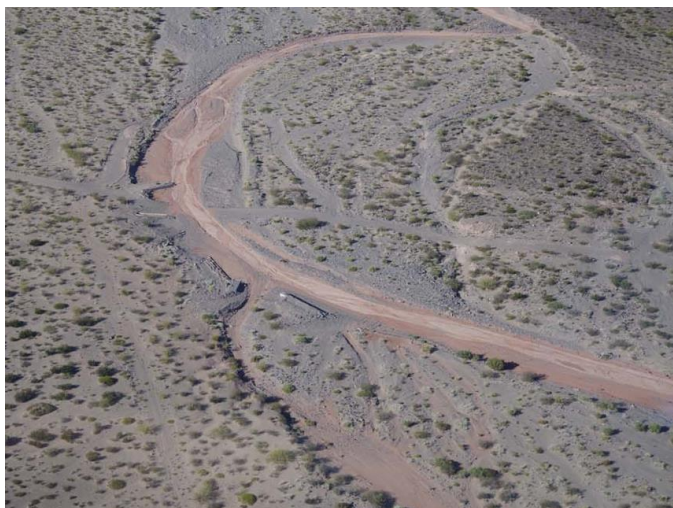
**FIGURE 32** Aerial view of completed work 3 – Source: Aereal patrol
