## IPG 2023-#0011

### "GEOTECHNICAL PROTECTIONS IN RIVER CROSSING, PK 20,500 PUESTO HERNÁNDEZ - LUJÁN DE CUYO - ARGENTINA OIL PIPELINE"

Leandro Ivorra<sup>1-2</sup>

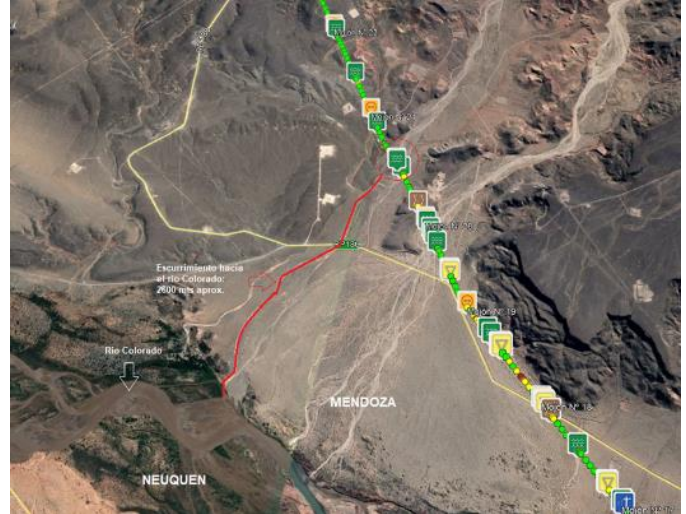
A risk analysis was carried out that showed the criticality of the pipeline. Within this analysis, design data, hydrological and tectonic hazards, among others, were included, and the possible environmental damage was also considered, since the pipeline is located approximately 2600 meters along the Colorado River. A failure of the pipeline in the PK under study would cause a spill on this important river that divides the provinces of Mendoza and Neuquén with the consequent environmental, economic impact and damage to the company's image. It should be noted that the Colorado River downstream has an important dam that supplies water to three important Argentine Patagonian provinces (Casa de Piedra Dam).

FIGURE 12 – Location of the pipeline in relation to the Colorado River– Source: YPF SA– Google Earth

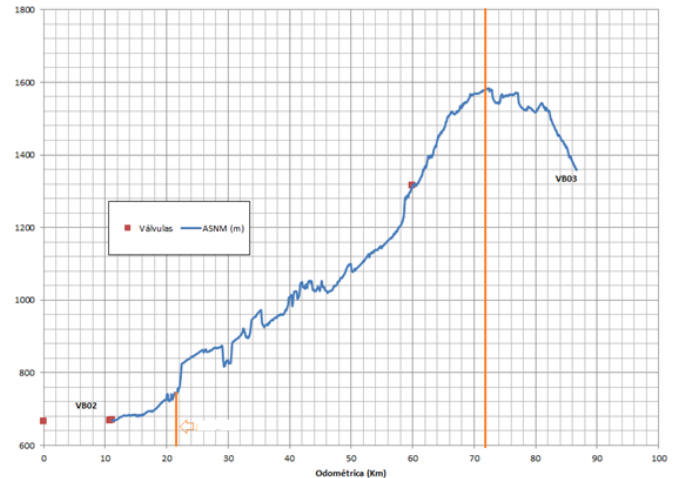
The nearest block valves are VB 2 pk 12 (9.1 km away) and VB 3 pk 88 (approx. 67 km away).

FIGURE 13 – Altimetry between VB – Source: YPF SA.

Depending on the altimetry of the area and the BVs present, a failure of the pipeline in the progressive in question would have meant a spill of more than 10,000 m<sup>3</sup> of crude oil.

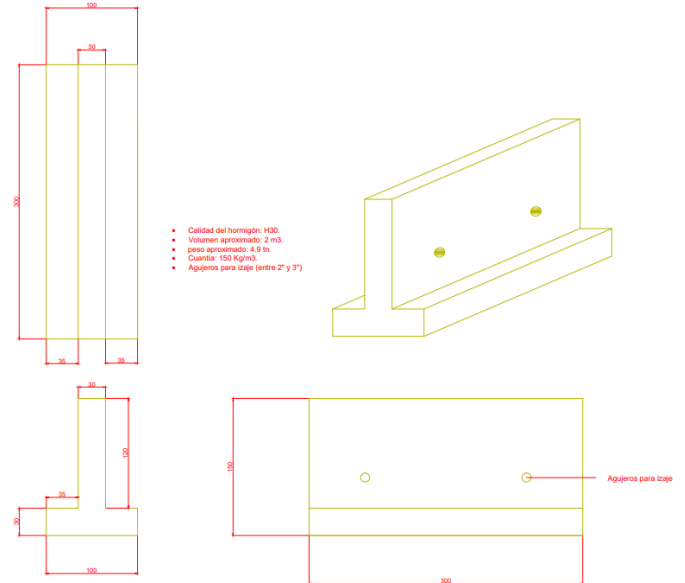
**FIGURE 17** -Sleepers Plans – Source: YPF SA

The materialization of the breakwaters was originally thought to be made using large stone blocks present in the place. As this was not possible, it was decided to make them with sleeper concrete blocks, which were detailed in FIGs 17 and 18

Once the solution had been chosen, it was necessary to study what material to make it with. This was limited to two options, which was to use large rocks similar to those used at sea or to use pre-cast elements of great weight and volume. Finally, he opted for the latter, which had to be manufactured so they had to be as robust and simple as possible. They were designed, calculated and sent to be built more than 400 km from the construction site.

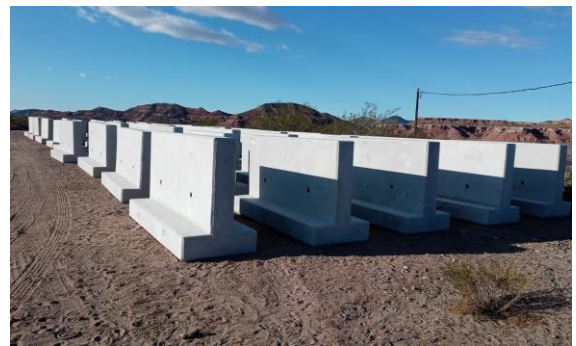
**FIGURE 18** – On-site sleepers – Source: YPF SA

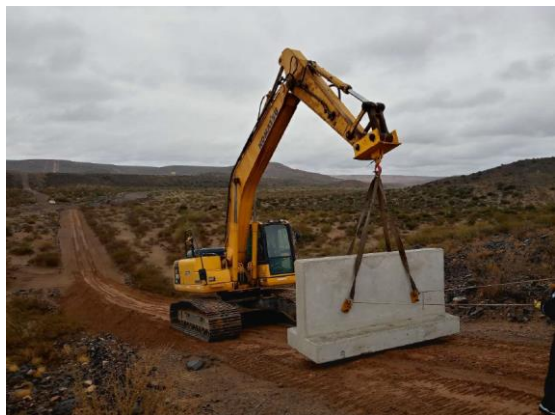
**FIGURE 19** – Equipment moving a sleeper –  
Source: YPF SA

The slope of a hill had to be changed by providing material so that trucks and other equipment could get around it and reach the foot of the work with the concrete blocks and the equipment itself.

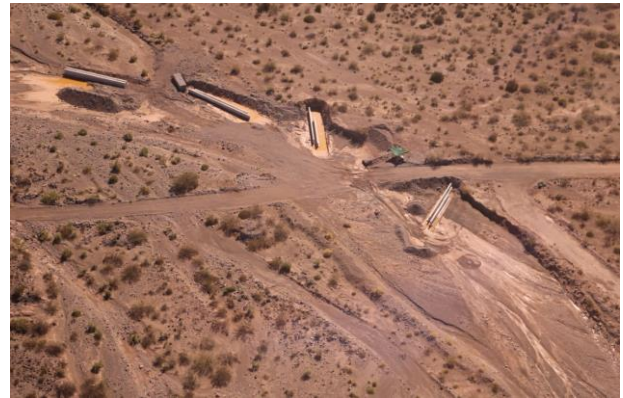
**FIGURE 25** – Aerial view of the construction site - Source: YPF SA

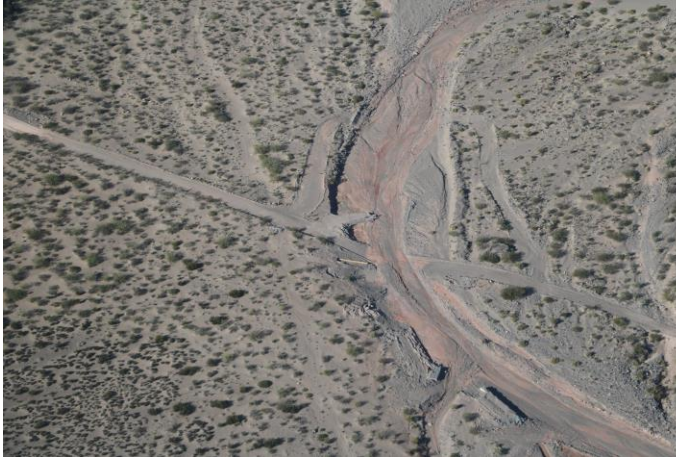
**FIGURE 31** – Aerial view of completed work 2 - Source: YPF SA

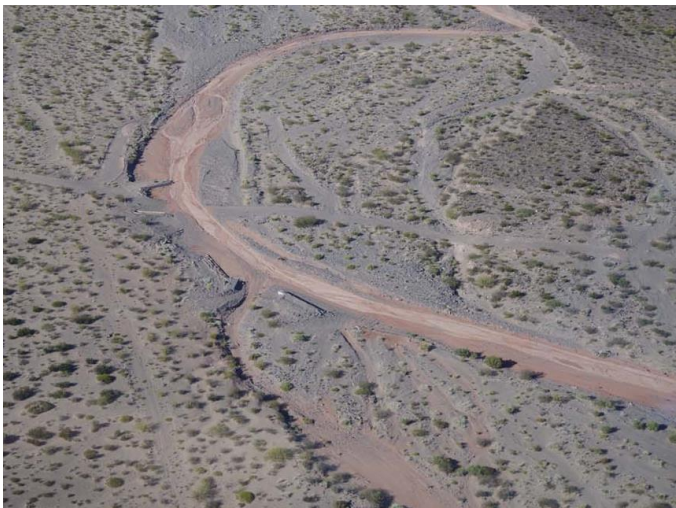
**FIGURE 32** Aerial view of completed work 3 – Source: YPF SA
