PREDICTIVE MANAGEMENT IN PIPELINE-TO-LANDSLIDE INTERACTION – A CASE STUDY

Carlos Motta¹, Jaime Aristizabal¹

¹CENIT Transporte y Logística de Hidrocarburos
Bogotá D.C., Colombia

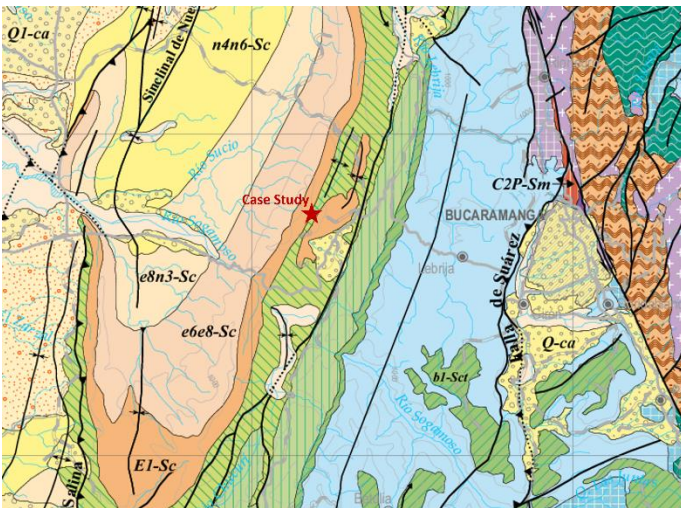
FIGURE 3. GEOLOGY OF STUDY CASE ZONE (SGC, 2023)

The study case site is located on the western foothills of the Eastern Mountain Range of the Colombian Andes Mountain, where Cretaceous rock of "Formación Umir" (gray to black carbonaceous shales with sandstone intercalations) are overlapping by Tertiary rocks of "Formación Lizama" (mottled shales with gray sandstone intercalations and some thin coal layers). On surface, there are Quaternary deposit like colluviums. (León, 1991) y (SGC, 2001). See **Figure 3**.

This site is in a complex and dynamic tectonic region by interaction of Nazca, Caribe, and South America tectonic plates. Due to this dynamic, intense fractured rock are present, as well as anticlinal and syncline structures limited by reverse and thrust faults.

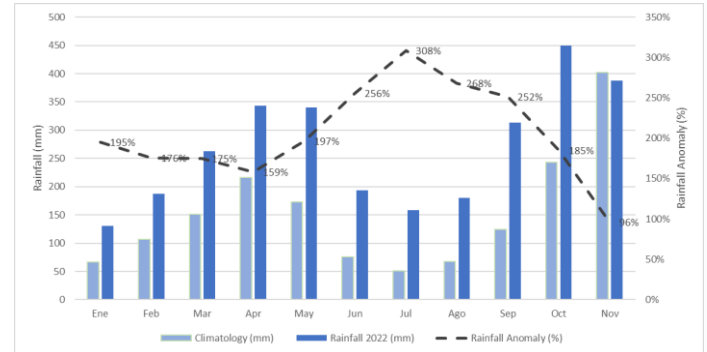
FIGURE 4. STUDY CASE AREA'S RAINFALL ANOMALY CHART.

CENIT has a rainfall network to monitoring its RoW's, through which an excess rainfall in case study area was identified. This was one of the reasons why frequent visual inspections were

carried out in the area. **Figure 4** illustrate previous months rainfall conditions compared with its climatology, for the study case area.

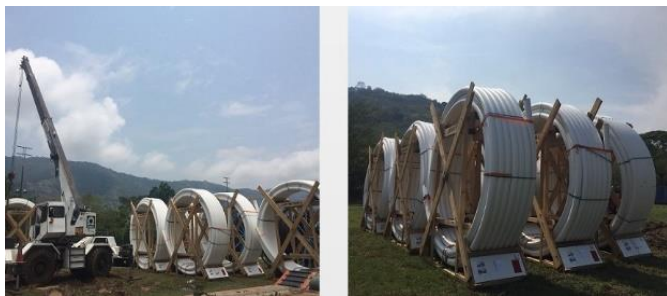
FIGURE 12. FLEXIBLE PIPE SPOOLS

A flexible pipe is a non-metallic pipe qualified for use in water, gas, and oil at high pressures, elaborated and certified under the API RP 15S standards. It is based on non-ferrous materials, so it does not corrode. Special anti-UV white that externally coats the pipe protects it from sunlight, so, it allows above ground or buried disposition. Flexible pipe is transported by means of spools (see **Figure 12**). **Figure 13** shown a temporary solution overview, installed and operative.

In an expert judge workshop, it was established that the most appropriate temporary solution for the conditions of the site was the construction of a bypass in flexible pipe.
