## AN INTEGRATED DECISION-MAKING PROCESS IN EMERGENCY CONDITIONS DUE TO GEOHAZARDS – A STUDY CASE

Carlos Pedraza<sup>1</sup>, Jaime Aristizábal<sup>2</sup>, Carlos Motta<sup>2</sup>

<sup>2</sup> CENIT, Transporte y Logística de Hidrocarburos  
Bogotá D.C., Colombia

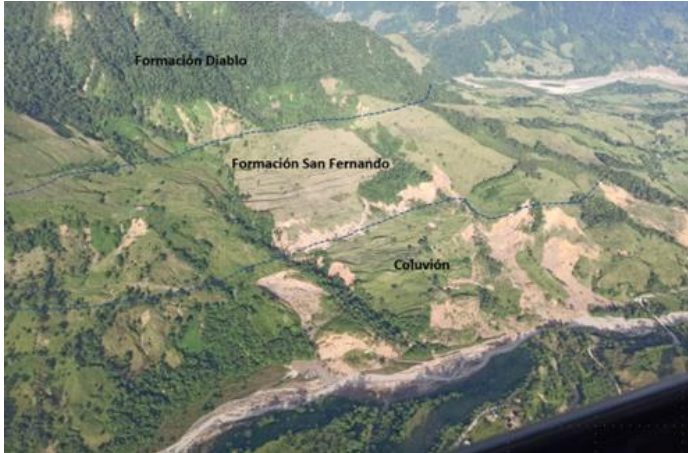
Scarp slope is formed in the upper part by hard white sandstone quartz that are part of “El Diablo” Formation and give rise to “Cortinas de Samoré”, and in the lower zone by gray clay trees of “San Fernando” Formation covered by coluvions, this condition is key to understanding hydrogeological model of the area (Figure 1 and [2]).

**FIGURE 1:** GEOLOGICAL ENVIRONMENT OF THE AREA (Photography by Lázaro Castillo).

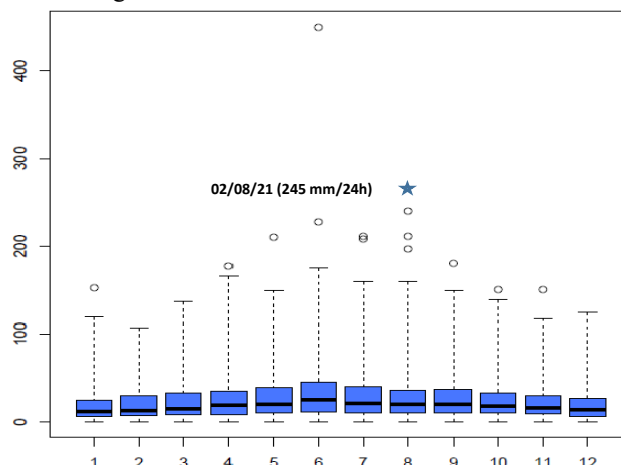
During August 2 and 3, there were extreme rains that exceeded the daily extreme upper limits recorded since 1972 by the IDEAM meteorological network, (Figures 5 and 6). In conclusion, it is identified that the event of August 2 reached the second highest rainfall recorded in the Santa Maria station and the fourth highest in the Tunebia station.

**FIGURA 5:** BOX PLOT FOR EXTREME DAILY ATYPICAL PRECIPITATION - SANTA MARÍA ABASTOS STATION (COMPARED WITH SAMORÉ STATION).

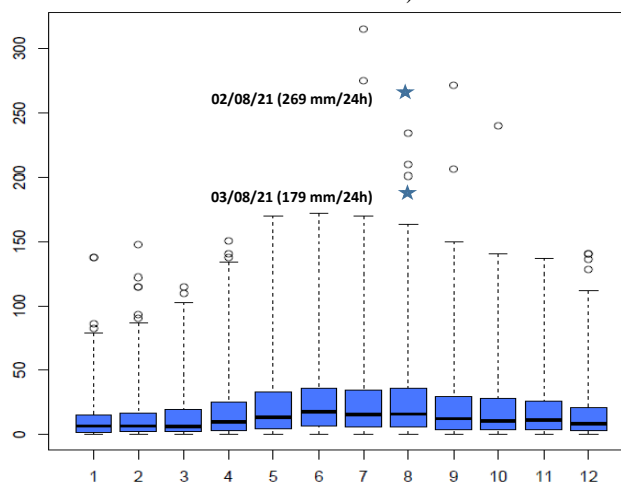
**FIGURA 6:** BOX PLOT FOR EXTREME DAILY ATYPICAL PRECIPITATION - TUNEBIA STATION (COMPARED WITH TROYA STATION).

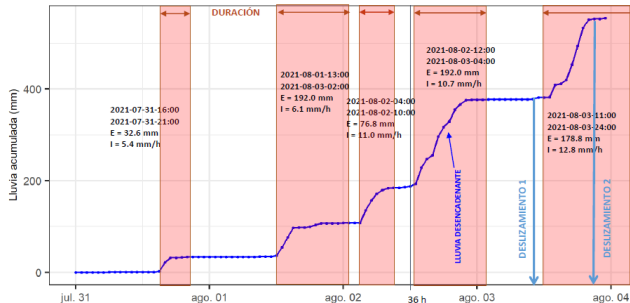
2023, at 11 am and ended on August 3 at 1 am, for a total rainfall of 314 mm (Figure 7) with hourly intensities that reached 34 mm. The event affected several villages in the Sarare area, impacting several towers of the 230-kW power line of the Toledo – Samoré – Banadía systems, the La Soberanía road at least in 8 points with total or partial closure and the Gibraltar – Bucaramanga gas pipeline affected in about 4 km. Additionally, there were dams and later avalanches in the La China and El Caraño streams (Figure 8).

**FIGURE 7: RAIN EPISODES IN THE 96 HOURS PRIOR TO LANDSLIDE EVENT**

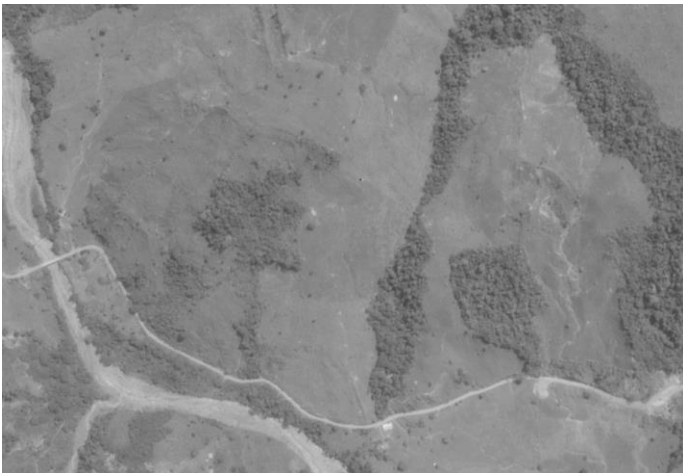
Additionally, a drainage network was built through channels on land covered with geomembrane in such a way as to avoid the percolation of water when cracks occur due to landslide rearrangement or by drying during the dry season. Indeed, based on the monitoring carried out and review of aerial photographs of 1982 – 1998 period (Figure 14), an interrupted drainage was identified in the wooded area located at main scarp, which had to be continued by means of concrete and stone channel that delivers to the stream that descends on the left flank of the landslide. In this way, the contribution of water that emerges in the transition rock-soil located on the main scarp was reduced.

FIGURE 14: AERIAL IMAGE - IGAC 1982.

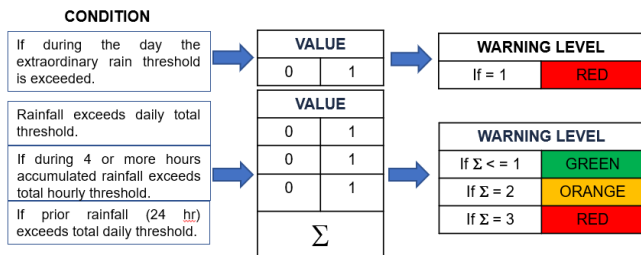
Based on recollected data values of atypical precipitation obtained with the historical series of rainfall, thresholds were defined that allowed generating a decision tree to define rainfall alert levels (Figure 15). To real-time monitoring, a weather station was installed less than 200 m from the left flank of the landslide.

FIGURE 15: DECISION TREE TO DEFINE THE RAIN ALERT LEVEL.

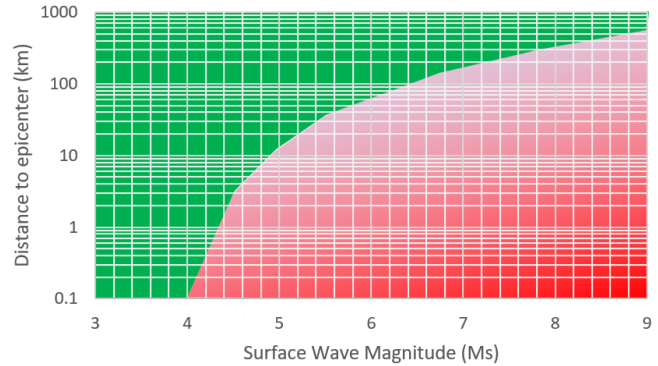
In the case of earthquakes, which are another of the main triggers of landslides, it was defined to use the monitoring network of the Colombian Geological Service and the alert threshold defined in Figure 16 will be handled, which uses as a basis the proposal made by Keefer (1984) [8] applying a

reduction factor to consider residual resistance parameters. In case of an event that is below this threshold, the red alert will be declared.

FIGURE 16: EARTHQUAKE-INDUCED LANDSLIDE ALERT THRESHOLD.

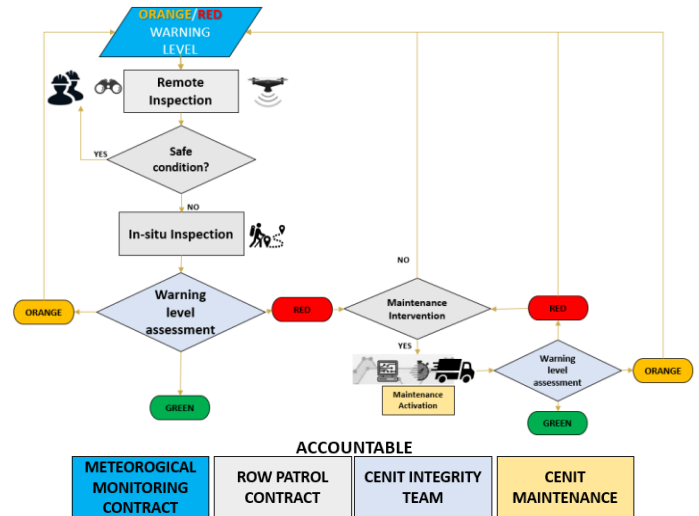
Depending on warning level, several actions must be executed, ranging from normal operation to pumping stop, as described below. For this purpose, a flowchart was defined where actions depending on the warning level (Figure 17) are established.

FIGURE 17: WARNING LEVEL ASSESSMENT FLOWCHART.

For a green warning level, the system is operated normally, and meteorological monitoring and right-of-way inspections continue without altering its periodicity.

When the orange warning is activated, detailed monitoring is made to the operational variables of the system. Drone inspection is done if weather conditions allow it or inspections from observation points away from the landslide. If this alert occurs during the night, pumping is suspended, but the pipeline is not drained.
